## EXECUTIVE SUMMARY

### ES.1 SUMMARY

The Bremer River catchment State of the Rivers survey, carried out in mid-1995, produced eight major findings:

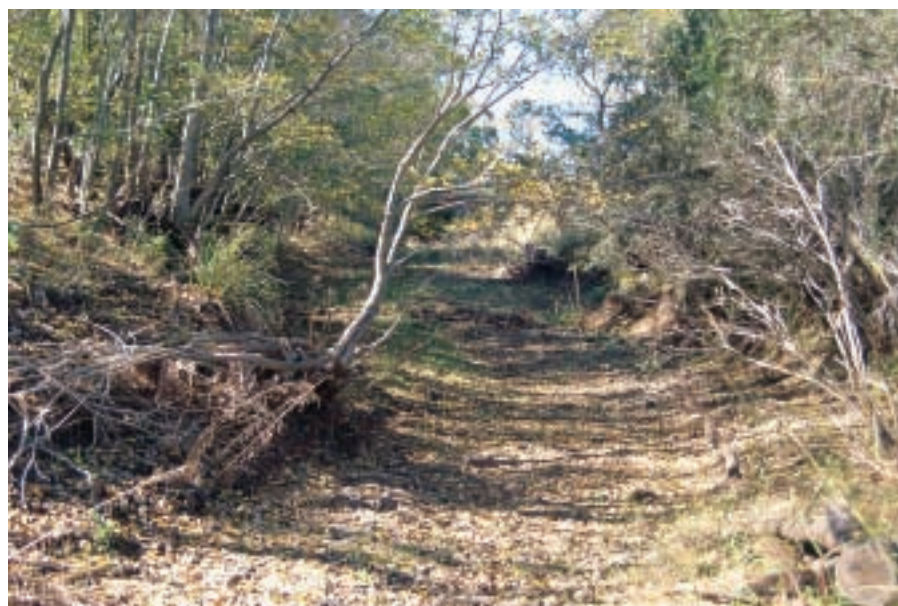
• Moderate bank stability: Bremer River (#47)

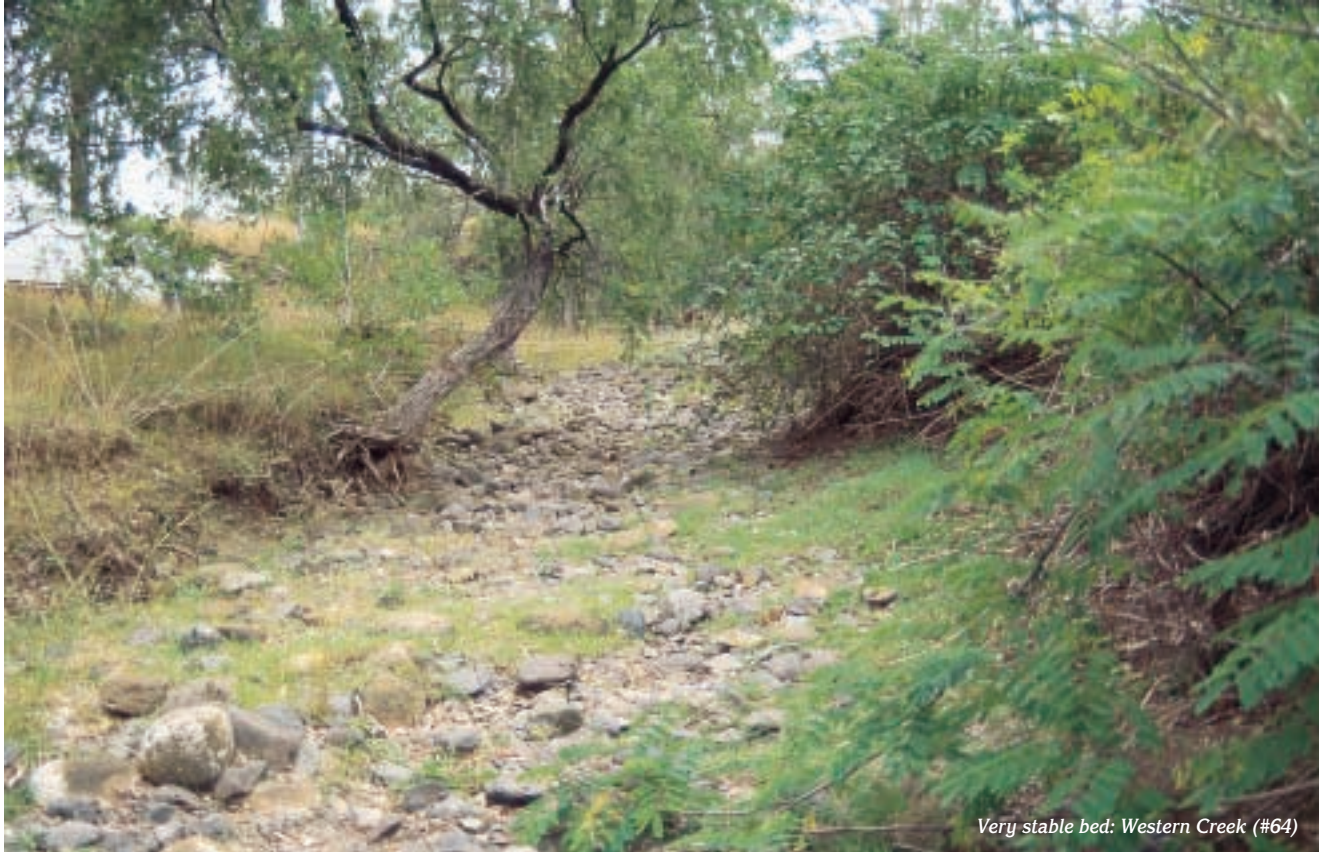
*Very stable bed: Western Creek (#64)*

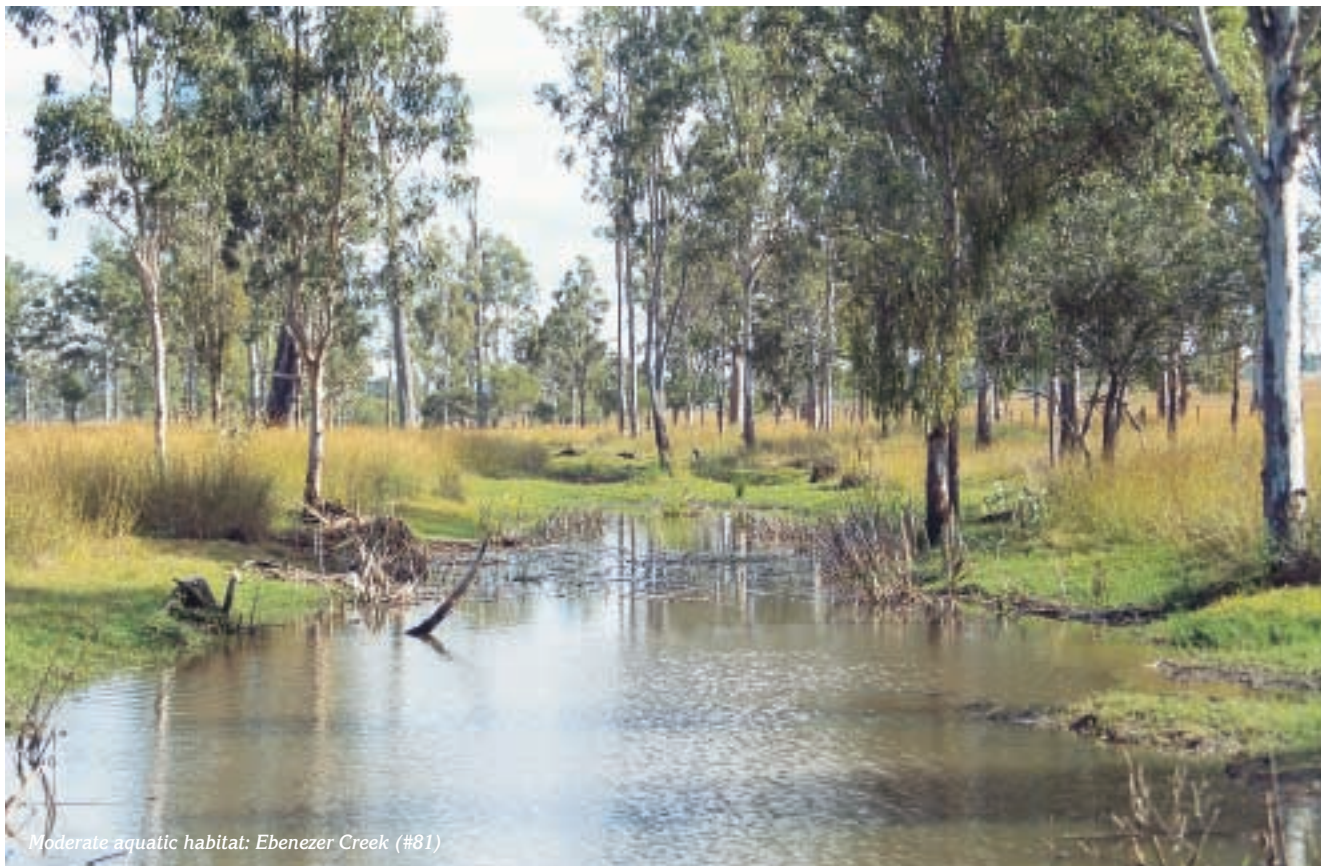
Moderate aquatic habitat: Ebenezer Creek (#81)

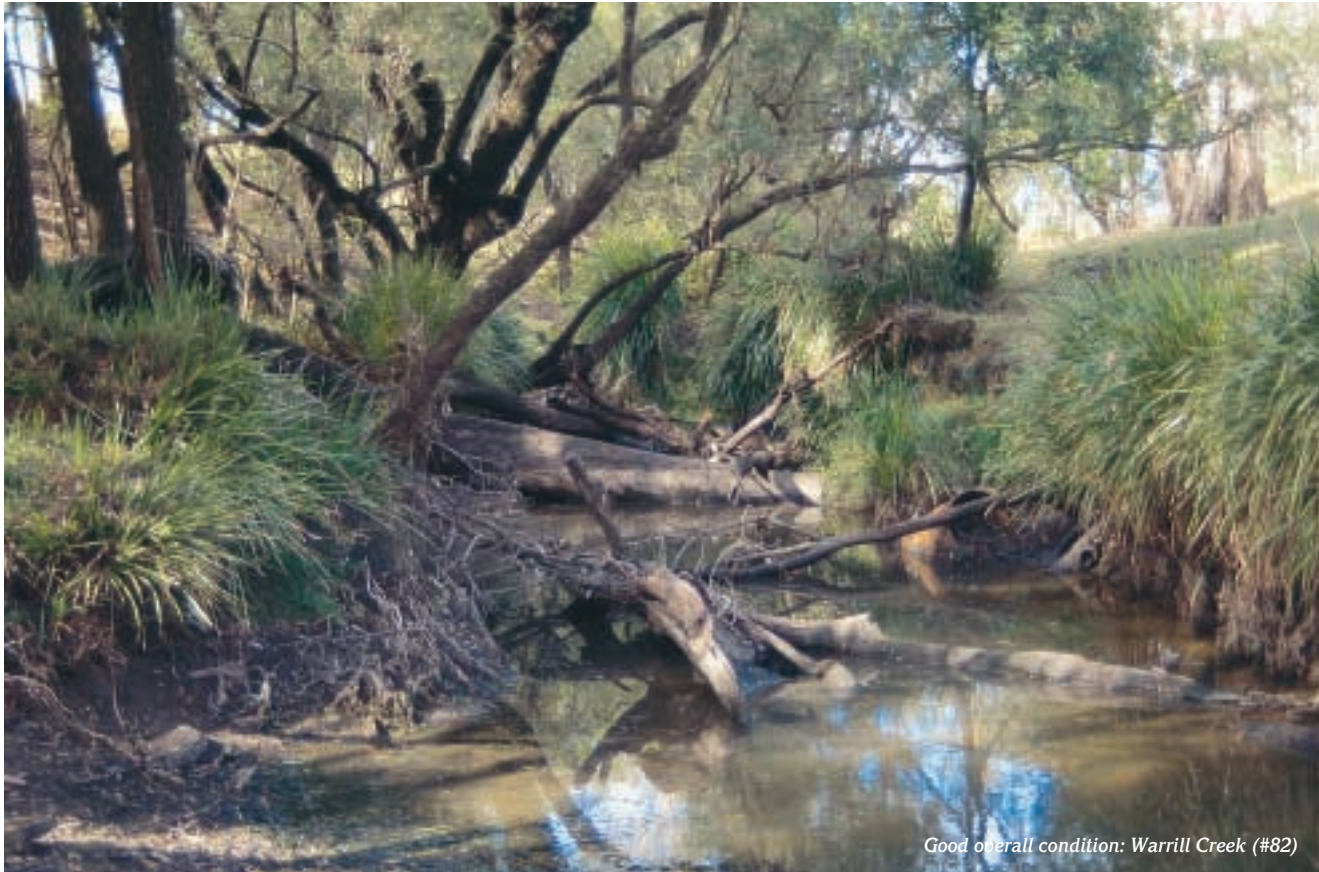
*Good overall condition: Warrill Creek (#82)*
