EXECUTIVE SUMMARY

ES.1 SUMMARY

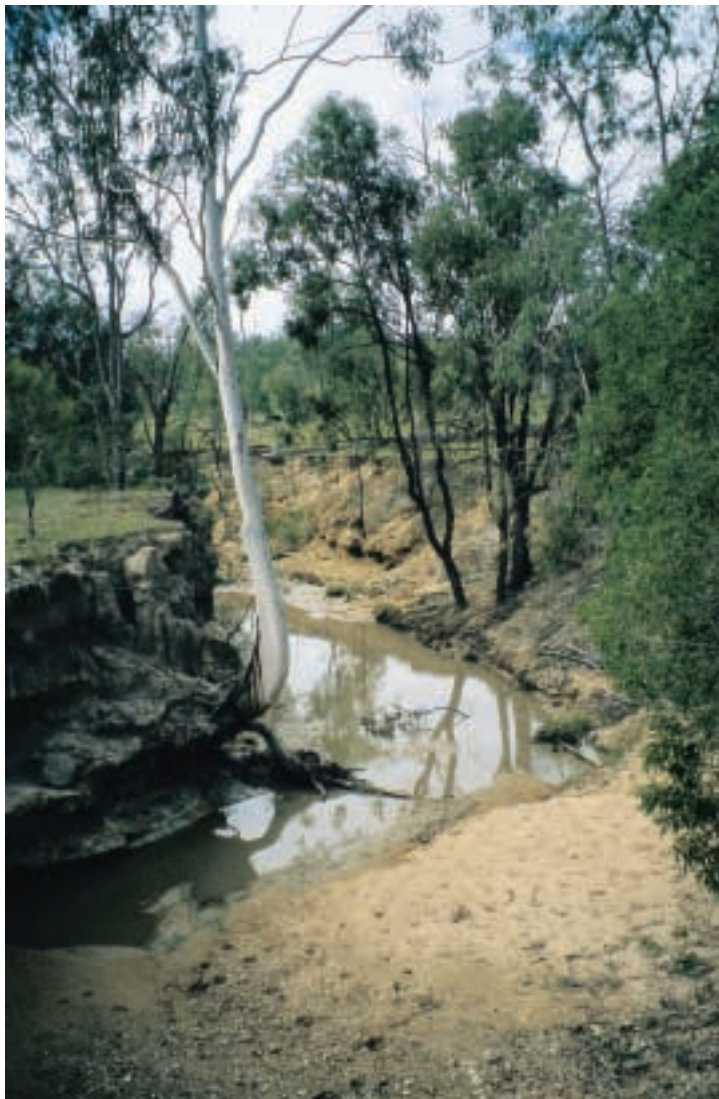
• Unstable banks: Mondure Creek (#274)

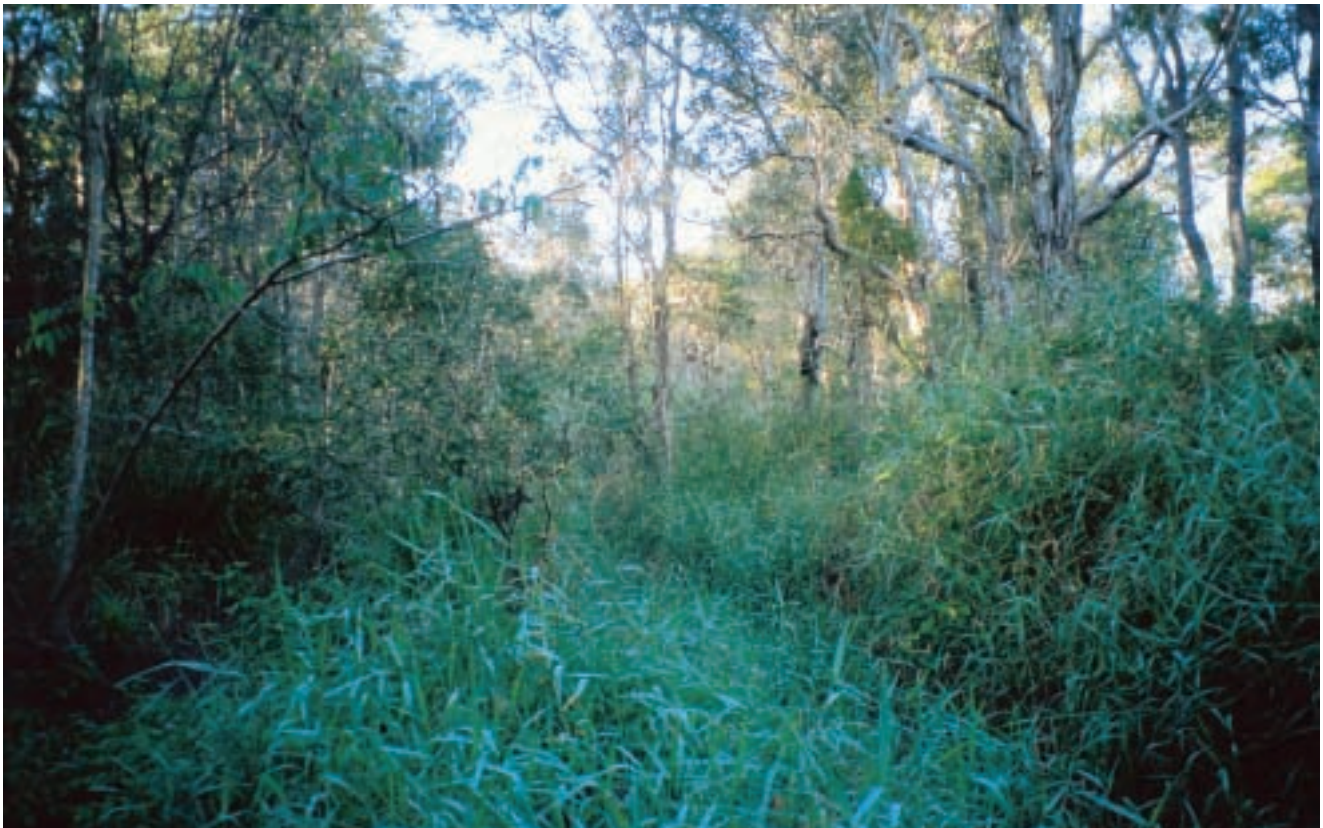
• Creek bed overgrown with vegetation: McCoy's Creek (#287)

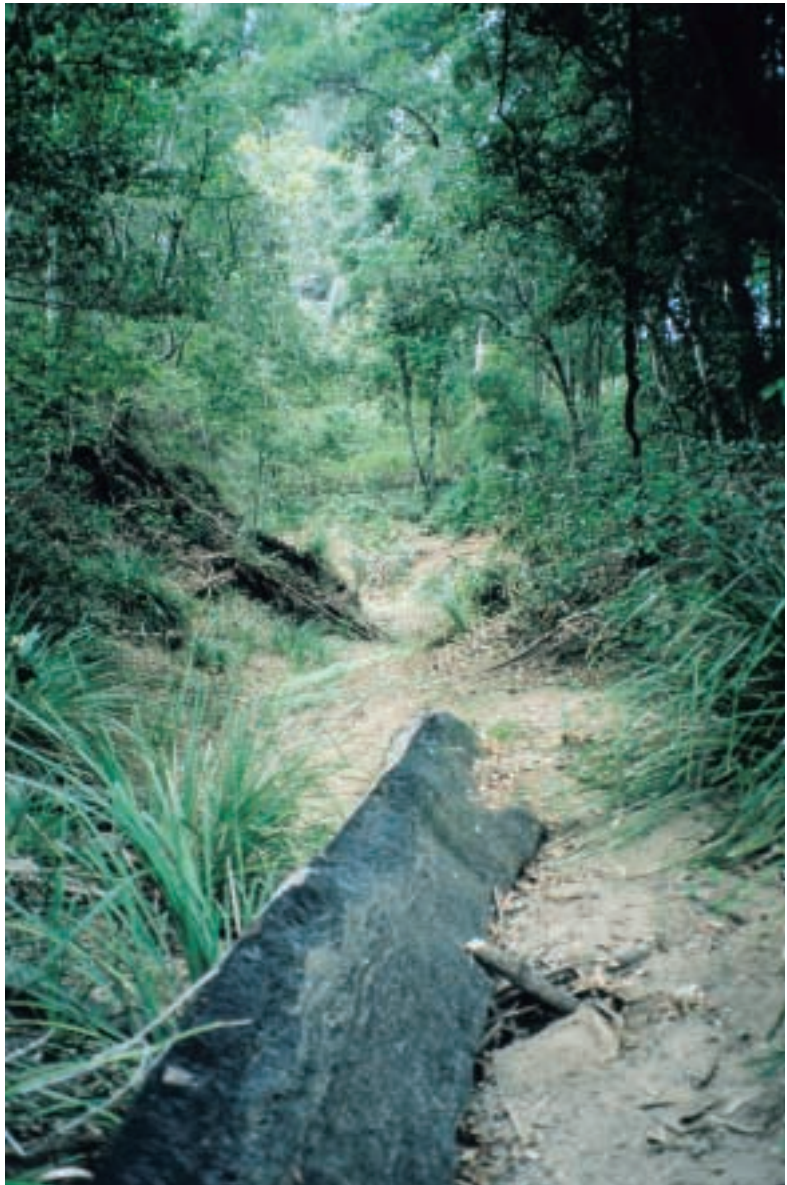
• Good scenic value: Cedar Creek (#38)
