EXECUTIVE SUMMARY

This report represents the second in a series describing the ecological and physical condition of a major river system in Queensland. The first study, of the Maroochy River catchment, provided a pilot for testing and validating the methodology developed by J.R. Anderson for the Department of Primary Industries, Queensland. The present report provides an assessment of the Upper Condamine River and tributaries, in terms of the physical and environmental condition of these streams at the time of survey, relative to the presumed pristine original condition of the catchment. Local remnant sites within the catchment that remain in very good condition give an indication of the original state of the whole catchment. The basic approach was to estimate the ecological condition in terms of the condition of the instream habitat. The condition of attributes recognised as being important to instream and riparian fauna and flora is surveyed.

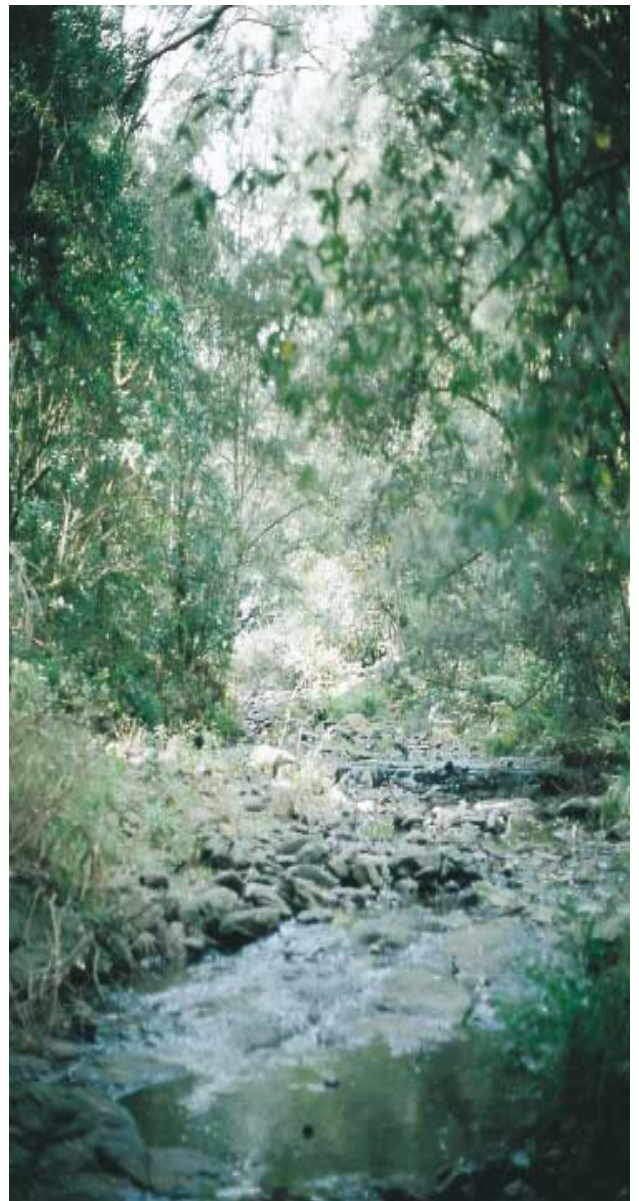
Stable beds (Dalrymple Creek)

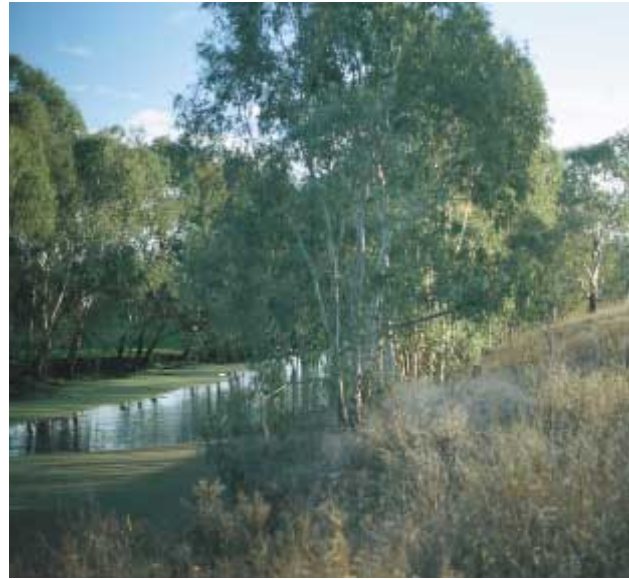
*Very poor riparian vegetation
(Condamine River upstream of Warwick)*

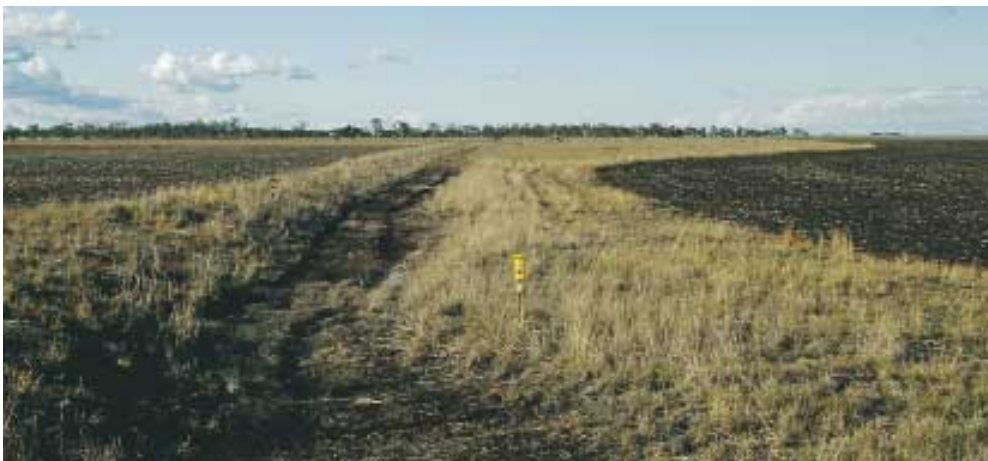
The condition of the reach environs was mostly very poor, as a consequence of natural drainage and channel modification, roading and grazing activities. Banks were generally stable to very stable, although erosion was recorded at all sites, occurring all along the banks and at bends. Clearing of riparian vegetation, roads, excessive flow to streams, presence of stock and runoff were identified as major disturbance factors. Beds were moderately stable to very stable, although erosion was recorded at all sites. Agricultural/grazing activities were the major disturbance factors identified. Channel diversity ratings were generally very poor, with runs constituting the dominant habitat type. The condition of the riparian vegetation was very poor, being dominated by herbs and grasses. Exotic weed species formed an average of 42% of the riparian vegetation and the riparian zone had a mean width of 8.8 m. Very little aquatic vegetation was recorded and hence the condition rating was very poor. The aquatic habitat rating of most stream lengths was very poor, with passage for aquatic organisms generally being very restricted. Scenic/recreation values were poor to moderate, as no current recreational activities were

Highly disturbed reach environs (Ashall Creek)

recorded and only a few potential activities being identified. The overall condition rating for the subcatchment was poor, suggesting that significant remedial action would be required to prevent further degradation. This could be in the form of planting of vegetation along river banks and fencing streams from cattle.

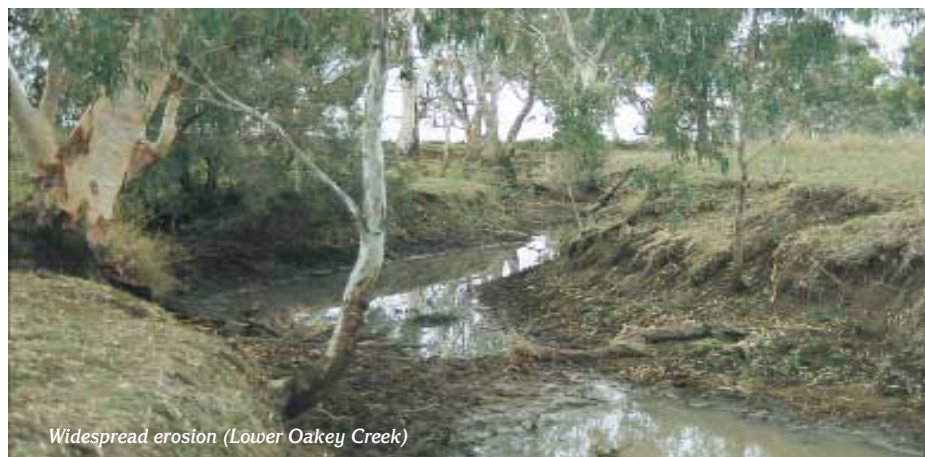
Widespread erosion (Lower Oakey Creek)

The condition of the Oakey Creek subcatchment is generally poor and remedial action will be required to prevent further degradation.

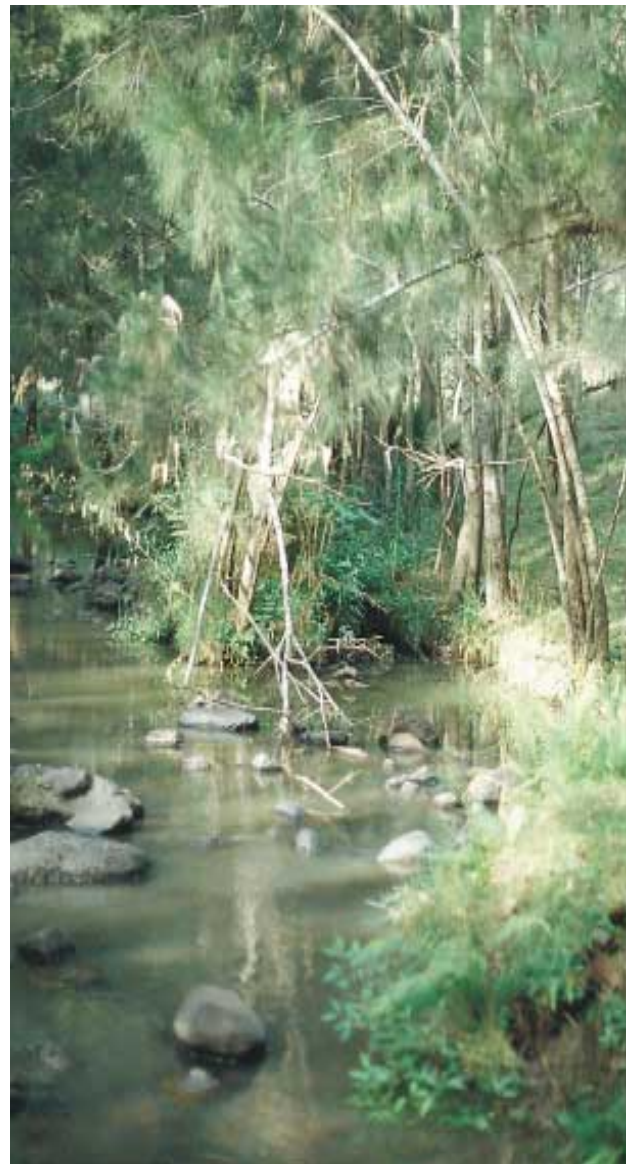
Scenic values (Condamine River upstream of Warwick)

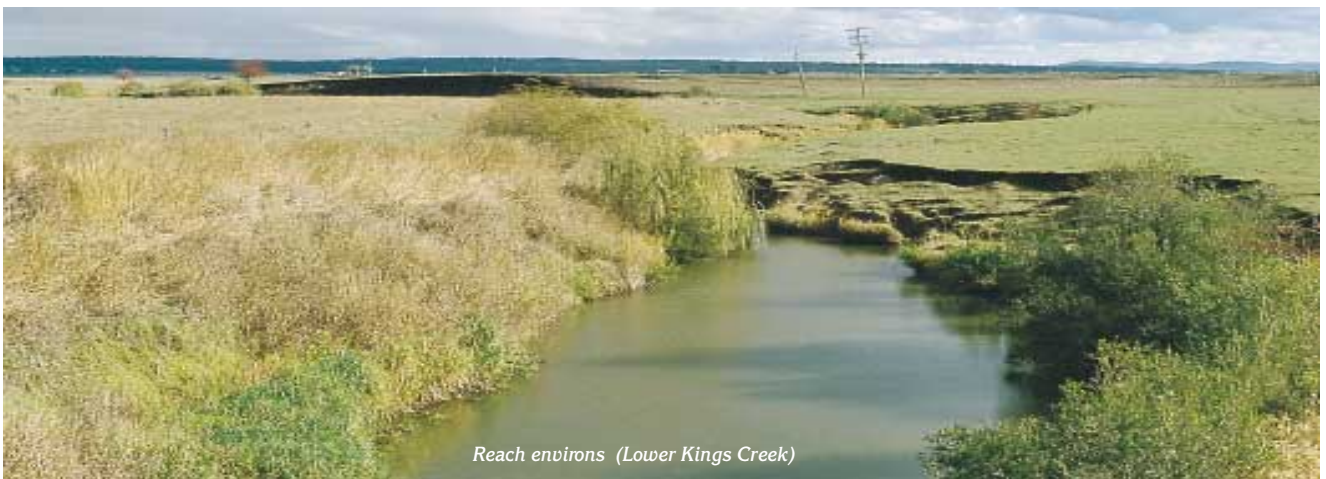
Very poor condition ratings for the reach environs were generally recorded. Grazing activities, roads and water extraction were identified as major factors leading to disturbance of the reach environs. Most banks were stable or very stable, although all sites recorded eroding banks, mostly all along the reach length. The presence of cattle was identified as the major disturbance factor. Beds were generally very stable, although erosion was recorded from most sites. Agriculture/grazing activities were the major factors affecting bed stability. Channel diversity was generally very poor, with pools constituting the

Reach environs (Lower Kings Creek)

Immediate remedial action is required in the upper subcatchment to prevent further degradation, while significant action is also required for the lower subcatchment.

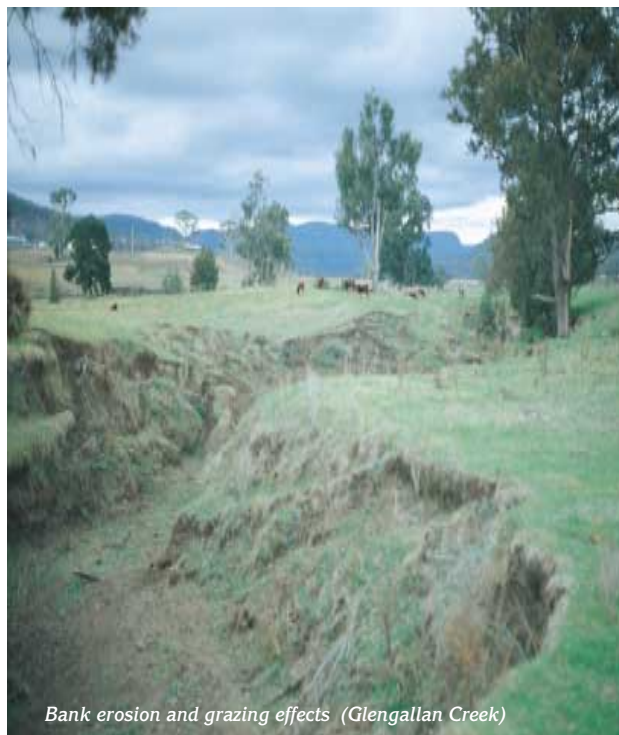
The condition of the reach environs was generally poor, due mainly to grazing activities. Bank stability was generally only moderate, with erosion being recorded from most sites, occurring all along the stream length or at bends. The presence of stock, excessive flow to streams and the clearing of riparian vegetation were all identified as major factors affecting the stability of banks. Bed stability was also moderate, with both erosion and aggradation being recorded. Erodibility of banks and agricultural/grazing activities were identified as major disturbance factors. Channel diversity was generally poor, with pools dominating and riffles being common. The condition of the riparian vegetation was generally very poor and was dominated by grasses, herbs and rushes. The riparian zone had a mean width of 14.7 m. Exotic weed species formed an average of 48% of the riparian vegetation. The condition of the aquatic vegetation was very poor. The condition of the aquatic habitat was very poor or good, although passage for aquatic organisms was generally very restricted. Scenic/recreation values were mostly moderate, with most sites having low or moderate scenic values and very few current recreational activities recorded (although the potential for recreation was considerable). The overall condition of this subcatchment was poor. The major remedial actions required to prevent further degradation include fencing from cattle and controlled access for watering, rehabilitation of the riparian vegetation and the implementation of a comprehensive weed control program.

Bank erosion and grazing effects (Glengallan Creek)
