EXECUTIVE SUMMARY

ES.1 SUMMARY

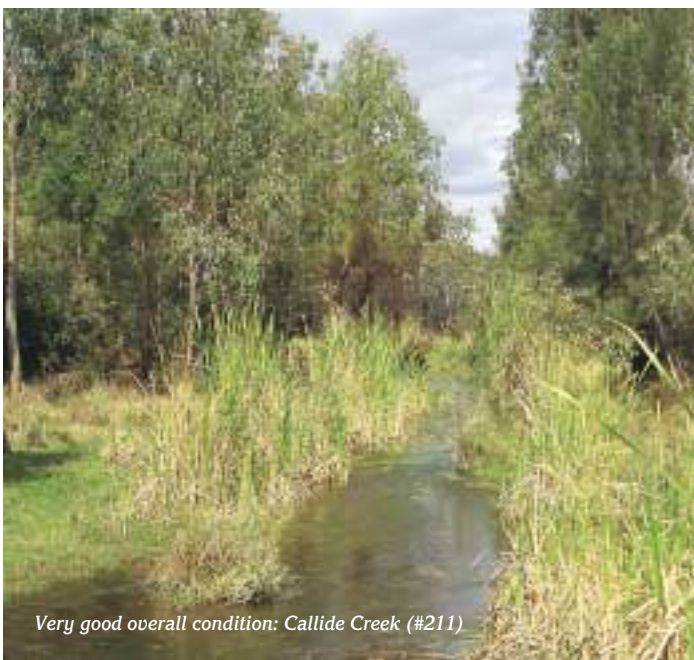
Very good overall condition: Callide Creek (#211)
