EXECUTIVE SUMMARY

ES.1 SUMMARY

The Lockyer Creek catchment *State of the Rivers* survey produced the following seven major outcomes.

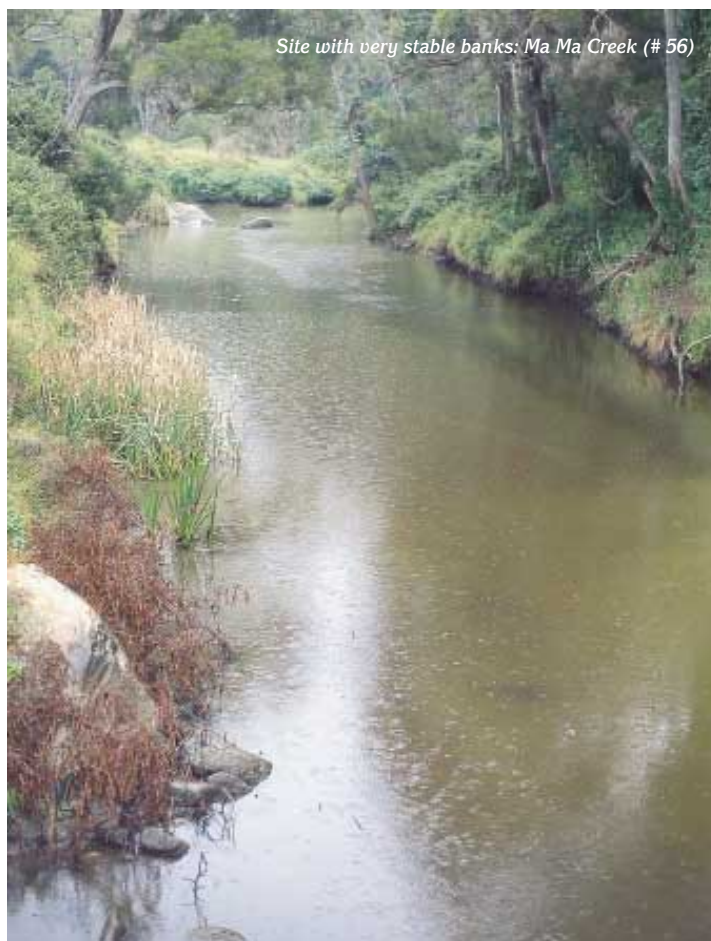
Site with very stable banks: Ma Ma Creek (# 56)

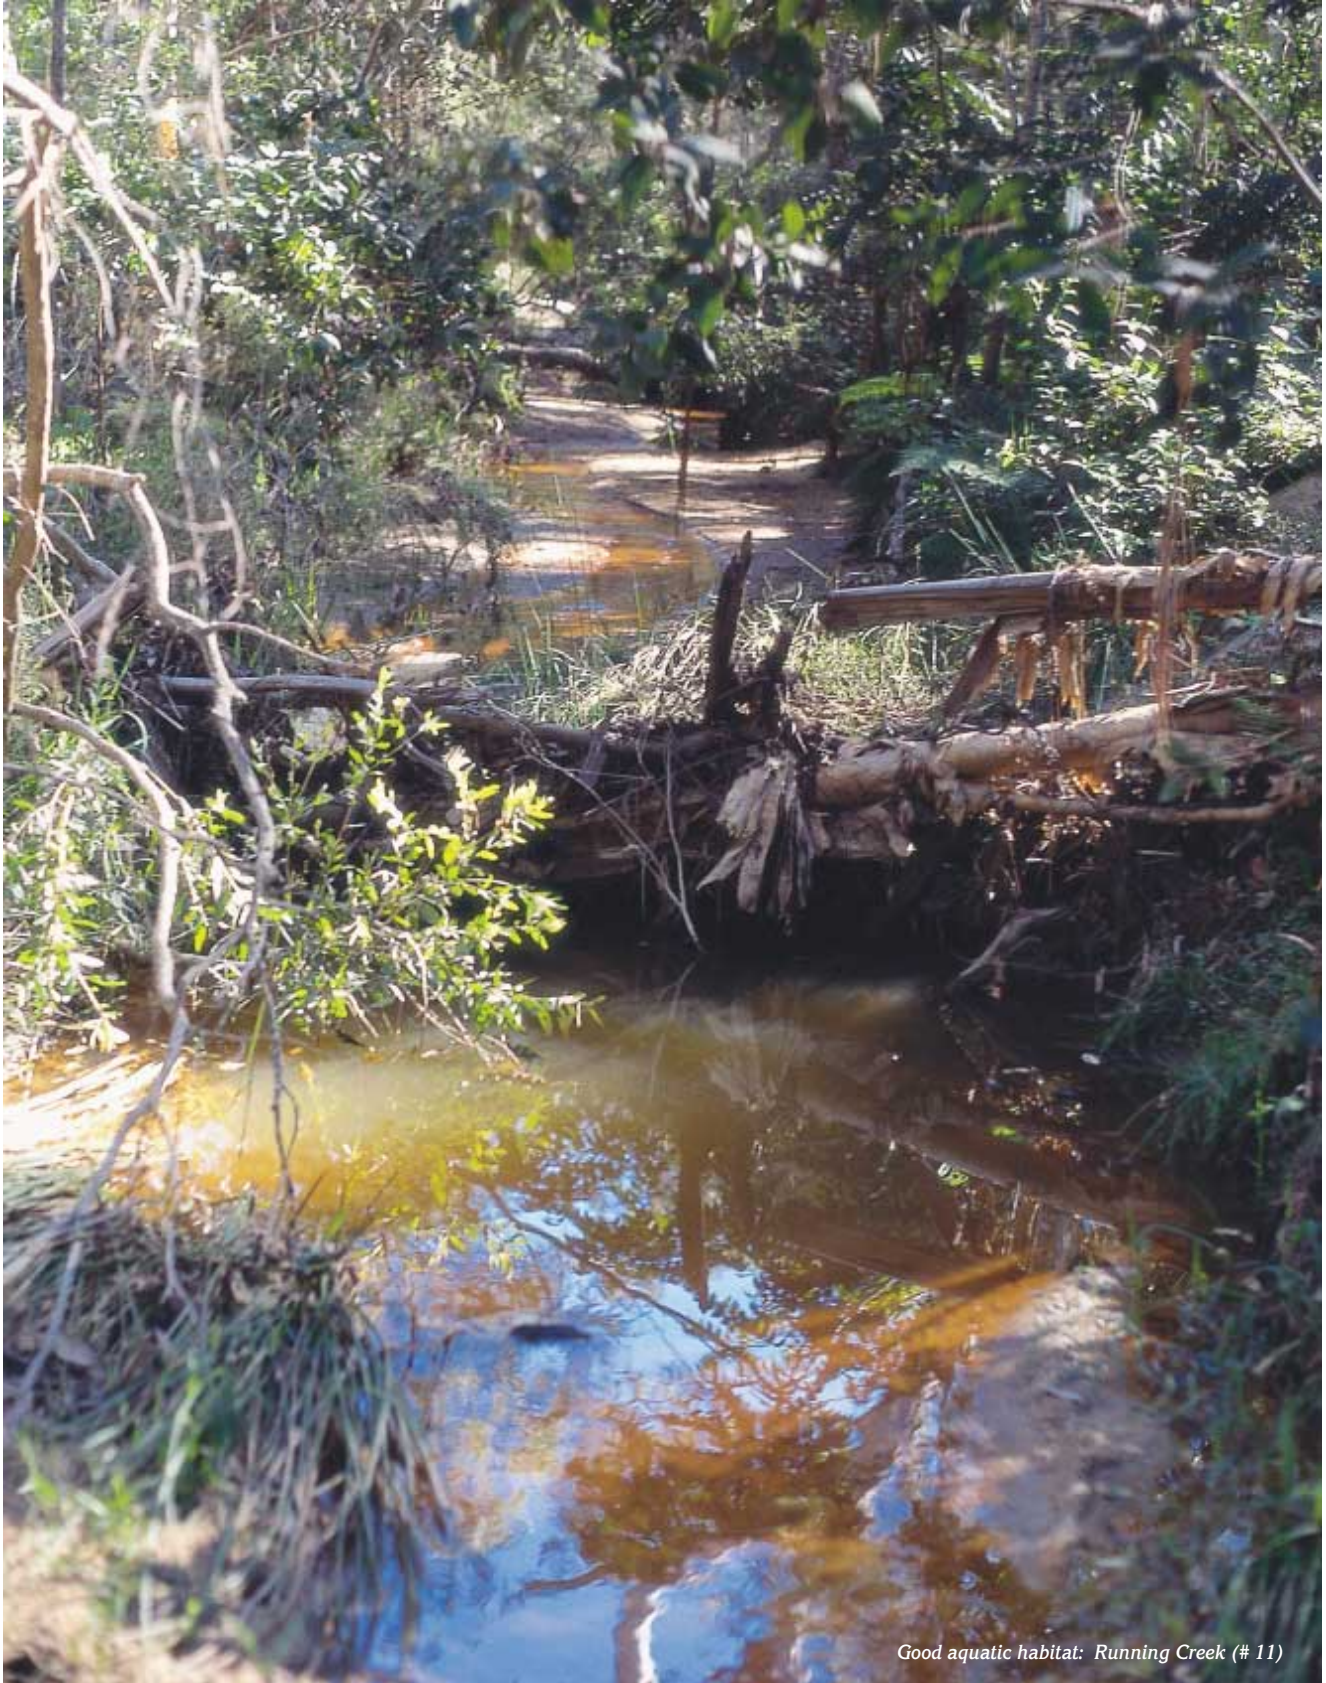
Good aquatic habitat: Running Creek (# 11)
