ECOLOGICAL AND PHYSICAL CONDITION OF THE LOGAN RIVER AND TRIBUTARIES

G I Moller

Resource Sciences Centre
Department of Natural Resources

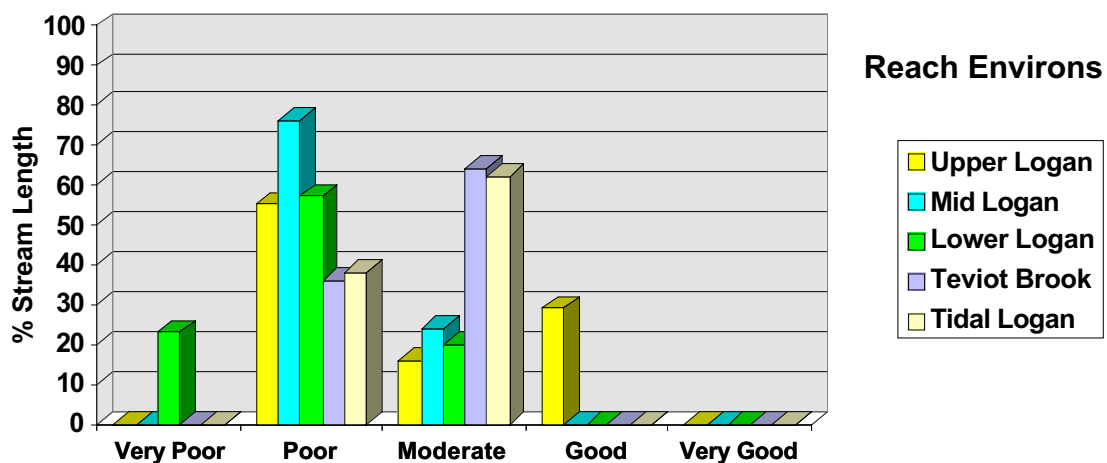
Figure 1 Reach Environs Condition

The condition ratings for the subcatchments are provided in Figure 1, which shows that generally the Reach Environs are in Moderate to Poor condition. There are some stream lengths in the Upper Logan subcatchment which are in Good condition and stream lengths in the Lower Logan subcatchment which are in Very Poor condition.

The higher percentages of stream length in Poor condition were in the Upper, Mid, and Lower Logan subcatchments while Teviot Brook and Tidal Logan subcatchments had higher percentages of Moderate ratings.

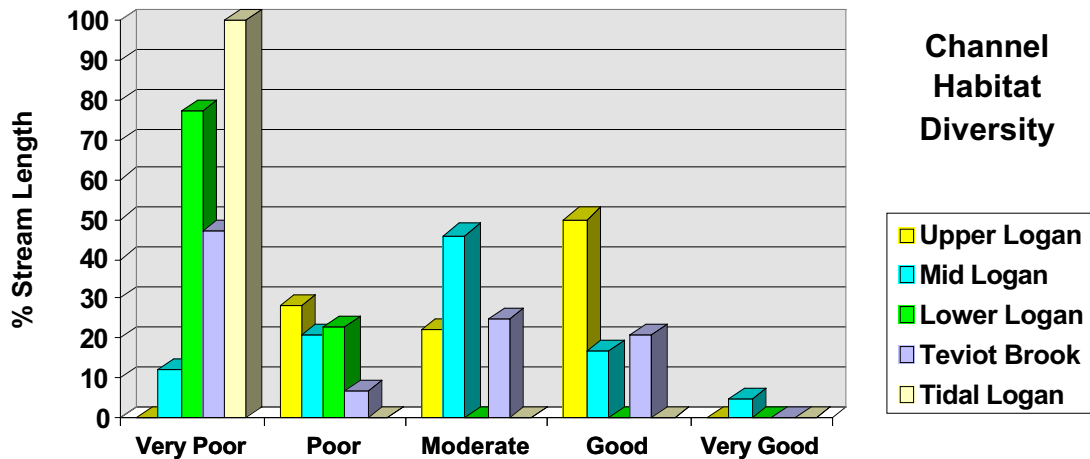
Figure 2 Channel Habitat Diversity

The Mid Logan subcatchment has a an almost standard distribution of diversity ratings through its length with the high proportion of stream length rated Moderate, Figure 2, (46% of stream length), Table 6, but with sections both Very Good, (5% of stream length) and Very Poor, (12%). The Lower Logan subcatchment has generally Very Poor diversity, 77% of the stream length, with the remaining 23% of stream length rated Poor diversity.

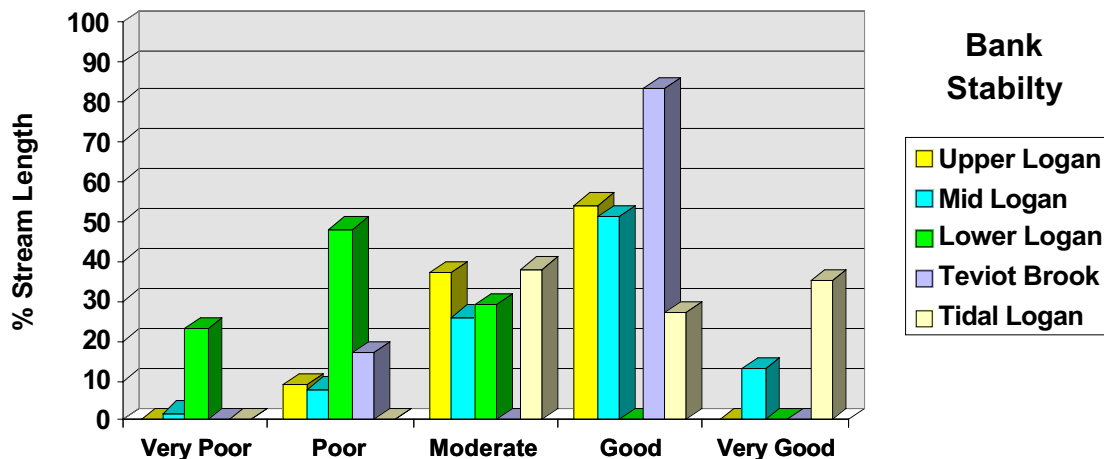
Figure 3 Bank Stability

Bank stability ratings through the Upper Logan, Mid Logan and Lower Logan subcatchments show a slight trend from the more stable end of the scale, at the upper end of the catchment, to less stable condition at the lower end of the catchment. The Upper Logan subcatchment ranges from 9% of stream length rated Poor to 54% Good, Figure 3 and Table 6. The stream banks were considered to be stable for 63% of their length and eroding along 30%, with these processes occurring at stream bends.

The Lower Logan subcatchment has classifications Very Poor, 23% of stream length, through Poor, 48%, to Moderate, 29%. By contrast to the two upstream subcatchments only 44% of the stream banks were stable but about the same length eroding, 28%. At 58% of stream banks surveyed slumping was recorded to be occurring along 20% of the bank length. Similarly at 58% of surveyed banks aggradation was taking place along 29% of the banks. The dominant process along the subcatchment stream banks was erosion along 100% of the banks. The action of these processes were to be acting all along the stream banks.

Teviot Brook subcatchment was predominately rated Good, 83% of stream length, with 17% classified as Poor. This is reflected in the recorded banks being 68% stable, with erosion recorded along 35% of the stream length. At 35% of stream banks surveyed aggradation was recorded to be occurring along 14% of the bank length. The action of these processes was recorded at bends and at obstacles.

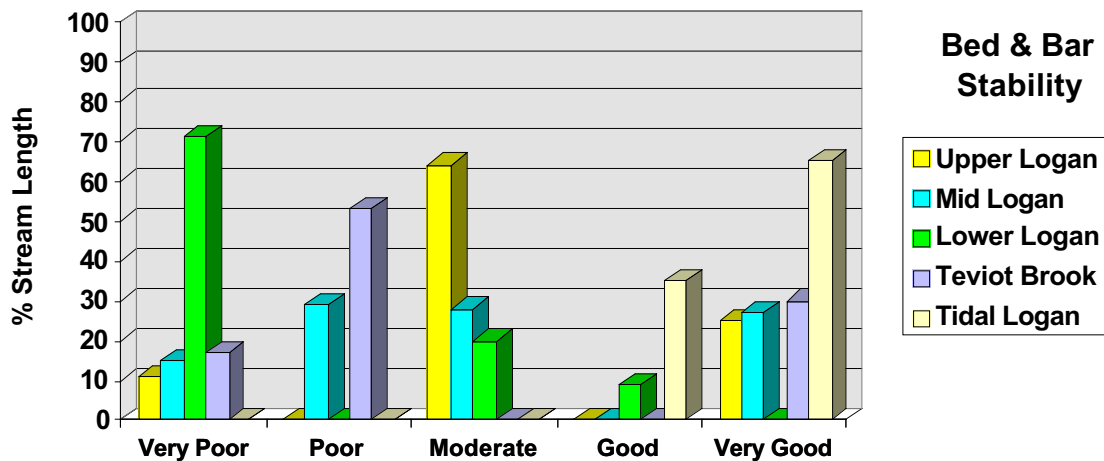
Figure 4 Bed & Bar Stability

Mid Logan subcatchment was generally more unstable than the Upper Logan with a greater tendency to the poorer ratings, Figure 4. This shows that 44% of stream length, Table 6, was rated Poor to Very Poor 28% Moderate and 27 % Very Good. The instability of the bed was due to aggradation processes with severe aggradation recorded at 22% of sites, moderate aggradation recorded at 61% and 17% of sites recorded as stable. Within the streams of this subcatchment bars were recorded at 89% of the sites surveyed, covering a mean 25% of the bed. The bars were recorded mostly as point bars, at obstructions in the bed and occurring alternately at 2 sites.

The Lower Logan subcatchment tends further to the poorer stability ratings, Figure 4, with 71% of stream length rated as Very Poor, Table 6. The instability of the bed was due to aggradation processes with severe aggradation recorded at 50% of sites and moderate aggradation recorded at 50%. Within the streams of this subcatchment bars were recorded at 83% of the sites surveyed, covering a mean 43% of the bed. The bars were recorded as bar plains and at obstructions in the bed. As seen by the increase in cover of the stream bed and the type of bars present the stream is more unstable and carrying a high load of sediment.

The Teviot Brook subcatchment is similar to the Lower Logan subcatchment in its rating of stability in that the majority of the stream length is rated Poor to Very Poor, Figure 4, with 70% of the stream length in these categories, Table 6. The remaining 30% is rated Very Good. The instability of the bed was due to aggradation processes with severe aggradation recorded at 30% of sites, moderate aggradation recorded at 40% and 30% of sites recorded as stable. Within the streams of this subcatchment bars were recorded at 70% of the sites surveyed, covering a mean 44% of the bed. The bars were recorded as point bars, at obstructions in the bed and as occurring alternately.

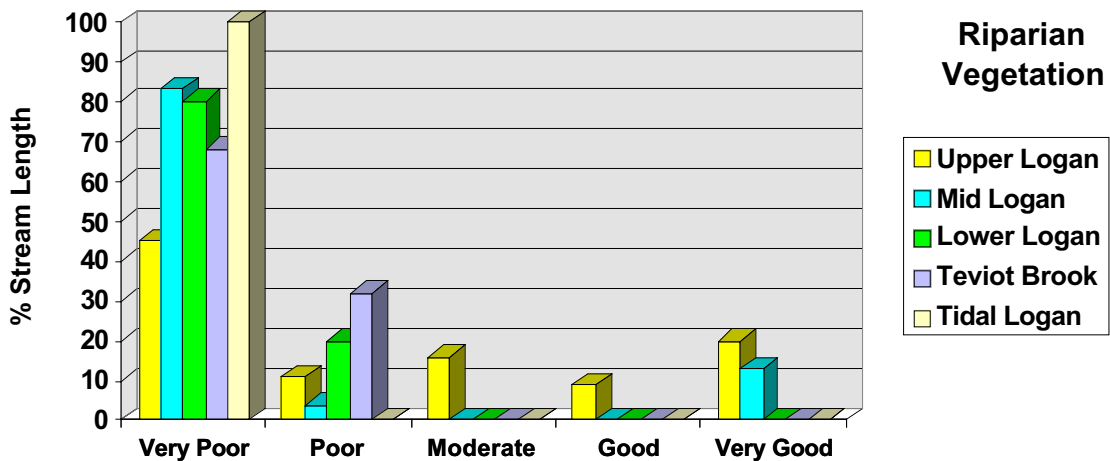
Figure 5 Riparian Vegetation Condition

Riparian vegetation condition ratings across all subcatchments were mostly Very Poor, Figure 5. The Upper Logan subcatchment did have better ratings than all of the other subcatchments, with 20% of the stream length rated Very Good, 9% Good, 16% Moderate and 11% Poor, Table 6.

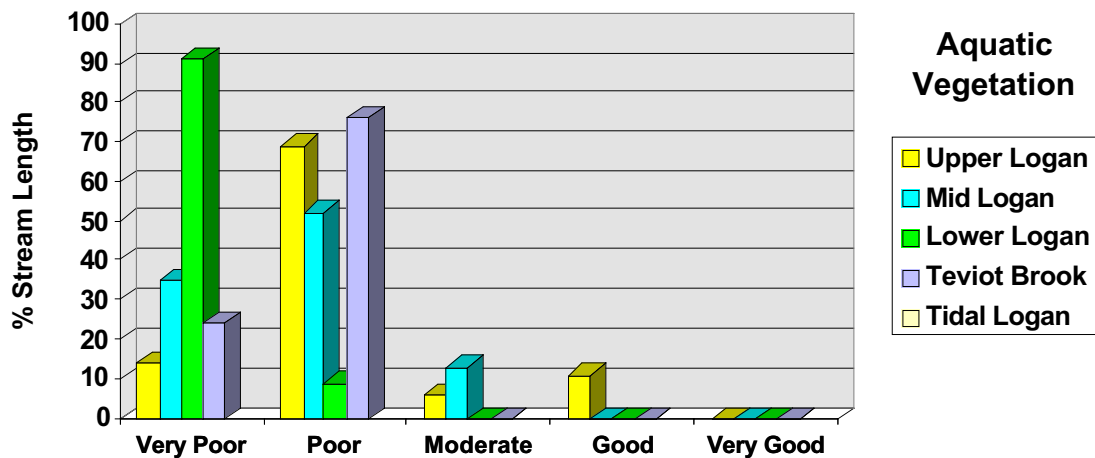
Figure 7 Aquatic Vegetation

There was very little aquatic vegetation within the streams which resulted in the condition ratings listed in Figure 7, which shows that all subcatchments are rated Poor to Very Poor. The best subcatchment for aquatic vegetation was the Upper Logan, which had 11% of its stream length rated Good, Table 6.

On the whole the streams were bare of aquatic vegetation for significant areas of the bed, Upper Logan streams were 57% bare, Mid Logan 65% bare, Lower Logan 88% bare, Teviot Brook 58% bare and there was no data for the Tidal Logan subcatchment.

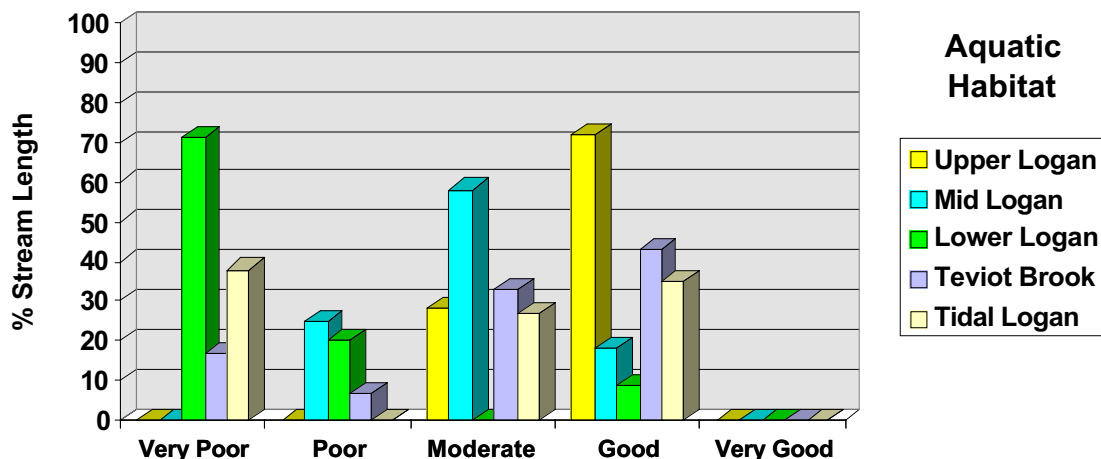
Figure 8 Aquatic Habitat Condition

The condition of the aquatic habitat has a similar trend to other attributes discussed above in that the Upper Logan subcatchment had generally better ratings than the downstream subcatchments, Figure 8, with 72% of its stream length rated Good and 28% rated Moderate, Table 6. The Mid Logan subcatchment had slightly worse ratings with ratings spread over Good, Moderate and Poor, with Moderate being the dominant rating.

Ratings for the Lower Logan subcatchment were worse still with the majority of the stream length rated Very Poor. Teviot Brook and Tidal Logan subcatchments both had condition ratings distributed from Very Poor to Good but tending to have a greater proportion of the stream length rated Moderate to Good. No subcatchment had ratings of Very Good.

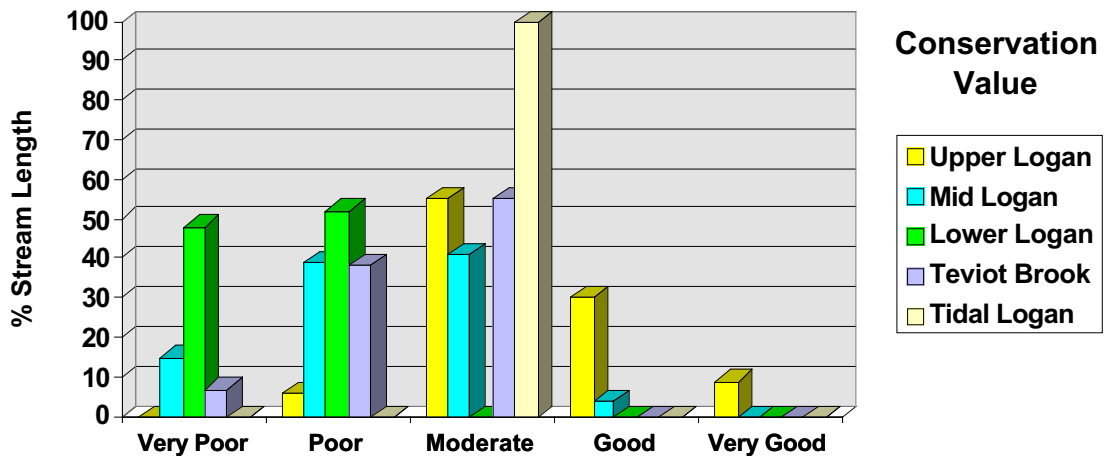
Figure 10 Conservation Value

The conservation values assigned to the streams follows a similar pattern to other stream attributes, in that the Upper Logan subcatchment has the larger sections of stream classified in the better end of the scale, although mostly Moderate, Figure 10, there is 9% of stream length Very Good and 30% Good, Table 6.

The Mid Logan subcatchment was classified mostly Moderate as well but the remainder of the streams were classified Poor and Very Poor, while the Lower Logan was classified Poor and Very Poor. Teviot Brook subcatchment was similar to the Lower Logan subcatchment and the Tidal Logan subcatchment was classified Moderate for its whole length.

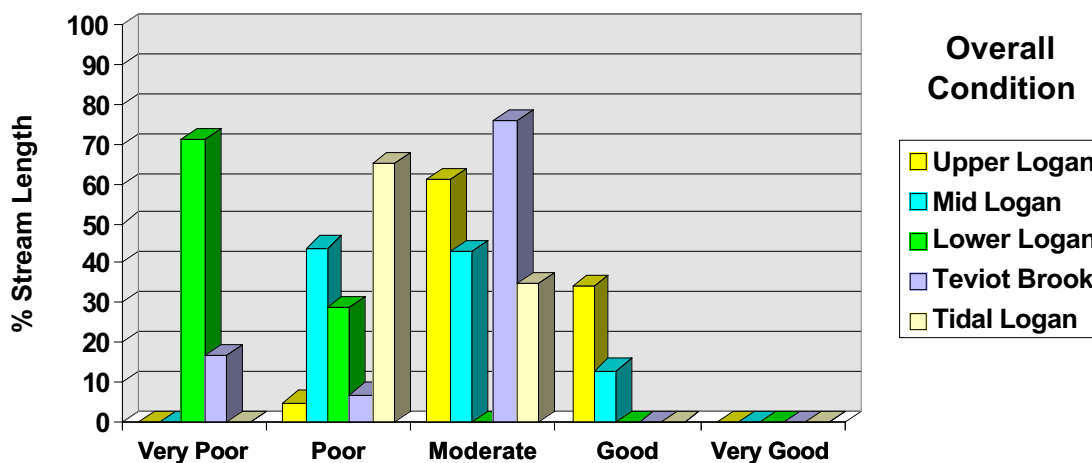
Figure 11 Overall Condition

The trend set in the individual stream attributes is obviously evident in the overall assessment when the attributes are combined. The Upper Logan subcatchment has the better overall assessment with the condition rating spread over the Poor, Figure 11, 5% of stream length, Table 6, Moderate, 61% and Good, 34%. Moving downstream the Mid Logan subcatchment was the next best ranging in rating from Poor to Good but with 44% of stream length classified Poor and only 13% classified Good. The Lower Logan subcatchment was all classified Very Poor and Poor, 71% and 29% of stream length respectively.

None of the streams surveyed were rated Very Good.
