The following report covers inspections of the Cyanobacterium, *Lyngbya majuscula*, in areas of Moreton Bay by officers of the Queensland Parks and Wildlife Service, local Councils and other observers. The inspections are to determine and report any changes in the coverage and density of Lyngbya

Central and Southern Moreton Bay – Surveys 11 and 16 December

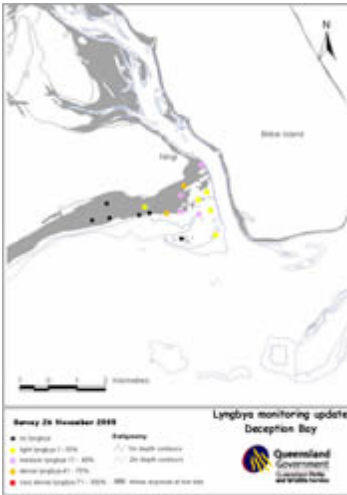
Greg Savige of Deception Bay completed the Lyngbya surveys for this report. The cover and density of Lyngbya growth in northern Deception Bay has progressively increased since October. The map below shows light to dense growth from **Sandstone Point** to **Cooks Rock** but no Lyngbya recorded off **Godwin Beach**. Please note the map below.

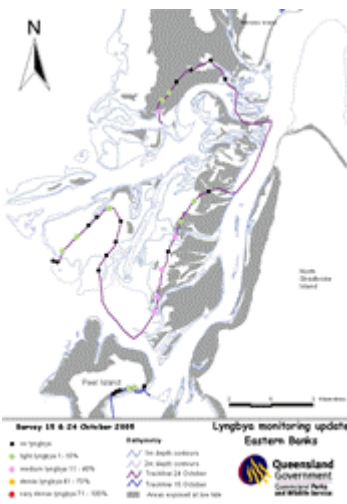
Patches of light and medium Lyngbya growth were observed emerging through eelgrass *Zostera capricorni* on the southern end of the **Moreton Banks** with similar new growth through seagrass and clear sand across the **Amity banks**. Lyngbya was also observed growing in **One Mile Harbour** and just off **Amity Point** of North Stradbroke Island.

The survey in **Horseshoe Bay** of Peel Island on 15 October revealed a few light patches but has since increased to medium Lyngbya growth with some rafting beginning to occur. Please note the map below.

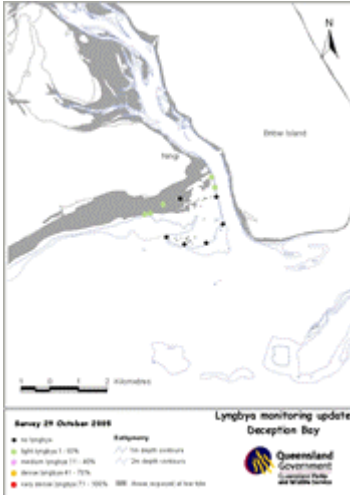
Greg Savige of Deception Bay completed two Lyngbya surveys for this report. The first in late September confirmed no Lyngbya growth but the second survey on 29 October showed the initiation of new light Lyngbya growing from **Sandstone Point** to **Godwin Beach**. Again this rapid growth has coincided with rising sea temperatures. Please note the second map below.

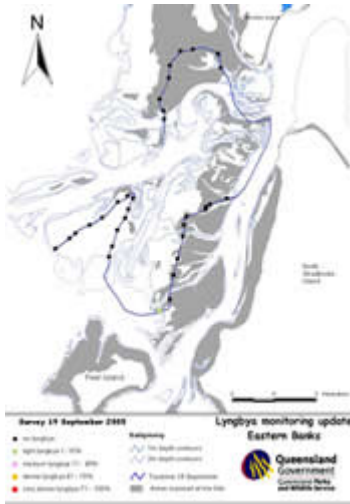
One very small patch of light Lyngbya was found at the western entrance to the **Dialba passage** on the Amity banks. No other Lyngbya was observed on this survey. Please note the following map.

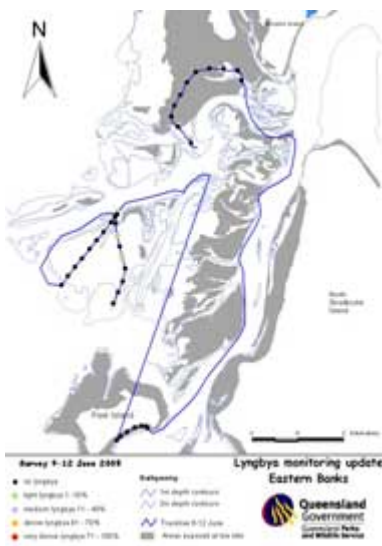
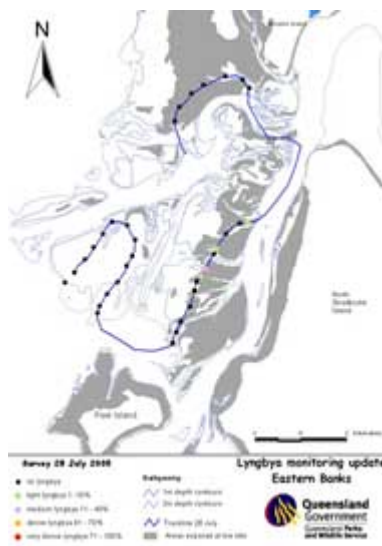
The cover and density of Lyngbya growth on the Eastern Banks has generally diminished from that observed in May. The following two maps show only light Lyngbya growth in a few locations on the Maroom and Amity Banks, no Lyngbya growth on the Moreton Banks and only one small patch of medium Lyngbya growth just south of the Coolooloo Passage in July. Horseshoe Bay of Peel Island was surveyed in June and was clear of Lyngbya growth. The survey period has coincided with uncharacteristic warm and wet conditions.

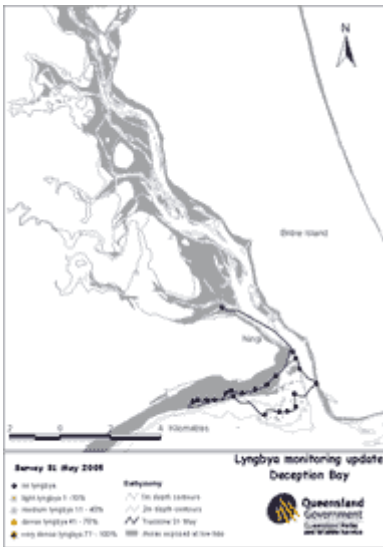
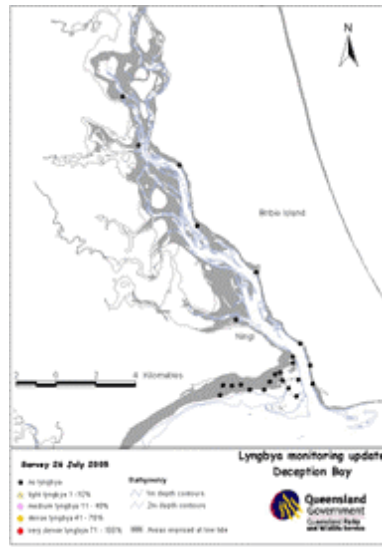
Surveys of Lyngbya growth in northern Deception Bay in the past two months have failed to locate any Lyngbya in the usual growth areas. Please note the sites surveyed in the following two maps.

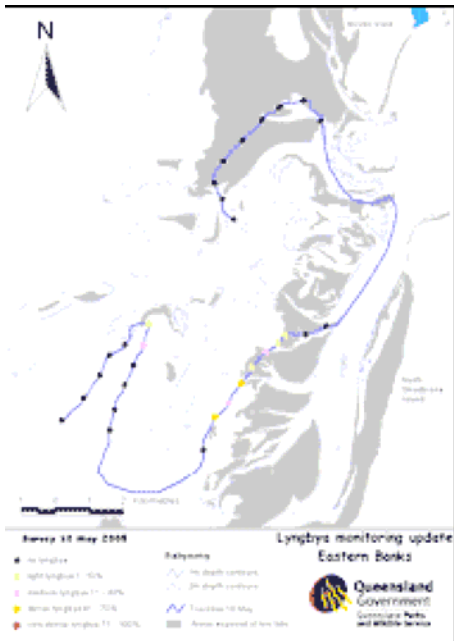
The cover and density of Lyngbya growth on the **Eastern Banks** has generally remained similar to that observed in March. The following map shows the significant patches of light to dense lyngbya persisting on the **Amity Banks** and smaller areas of light to medium growth on the northern section of the **Maroom Banks**. It is interesting to note that the Lyngbya growth is quite new and the water temperature in the areas surveyed averaged around 21? C. The light lyngbya growth observed on the **Moreton Banks** in March was not seen on this occasion. Please note the map below.

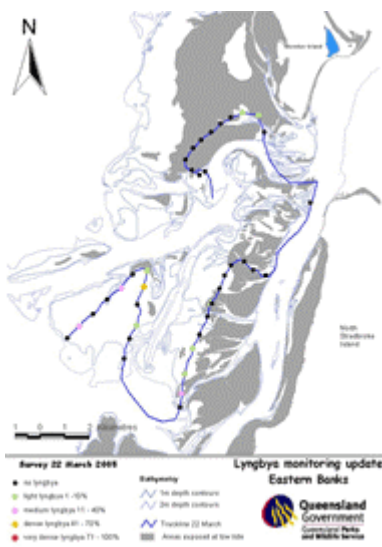
There has been a general increase in Lyngbya growth on the Eastern Banks in the past month. The survey results of 22 March 2005 are presented in the following map and show patches of light Lyngbya growth spread across the survey area of the Amity and Moreton Banks. There was one large area of dense new Lyngbya growth on the northern section of the Maroom Bank and several patches of medium density Lyngbya on the Maroom and Amity banks. Please note the map below.

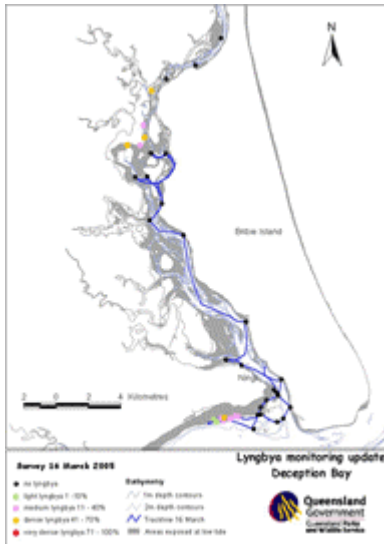
The survey results of 16 March in Northern Deception Bay show small floating mats of Lyngbya south of Tripcony Bight and light to dense new Lyngbya growth out from Godwin Beach. The Caloundra City Council inspected the northern section of the Pumicestone Passage on 23 March and found new medium to dense Lyngbya growth from Tripcony Bight to Coochin Creek and small floating mats of Lyngbya in the northern section of the passage. Please note the following map.

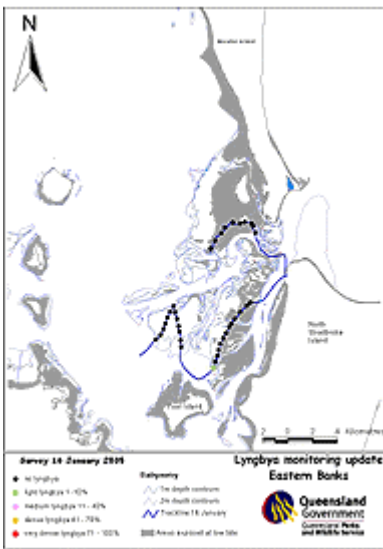
The Eastern Banks were surveyed for the presence and cover of Lyngbya on 16 January 2005. The extensive cover of Lyngbya noted from the previous survey of 23 December has all but disappeared in the areas surveyed. A very small and light cover patch of Lyngbya was found at south western entrance to the Dialba Passage on the Amity Banks and some floating tufts were found on the Boolong Bank. Please note the map below.

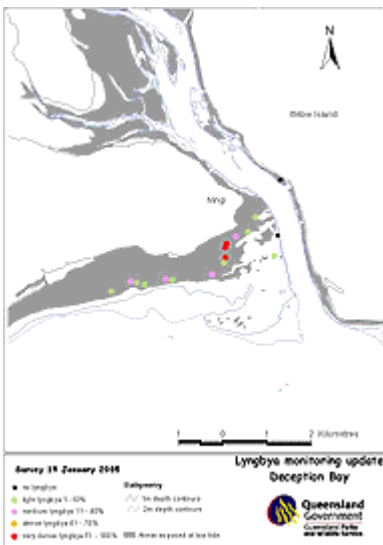
Surveys of Lyngbya growth were conducted in northern Deception Bay in the past few weeks where Lyngbya has continued to cover large areas of the shallow banks in front of Godwin beach through to Sandstone Point and out to the third starboard marker south of the Bribie Island bridge. The most recent survey conducted 19 January and shown below on the map provided, noted that light to very dense lyngbya was present in this triangular area and was mainly new growth with strands approximately 15cm in length.

The Caboolture Shire Council is undertaking regular inspections of foreshore in this area and has implemented shoreline cleanup and disposal of large amounts of deposited Lyngbya from Beachmere to Sandstone Point and Red Beach on Bribie Island.
