**Case Studies**

**“Irrigation for Profit”**

**June 2003**

**Appendix 5**

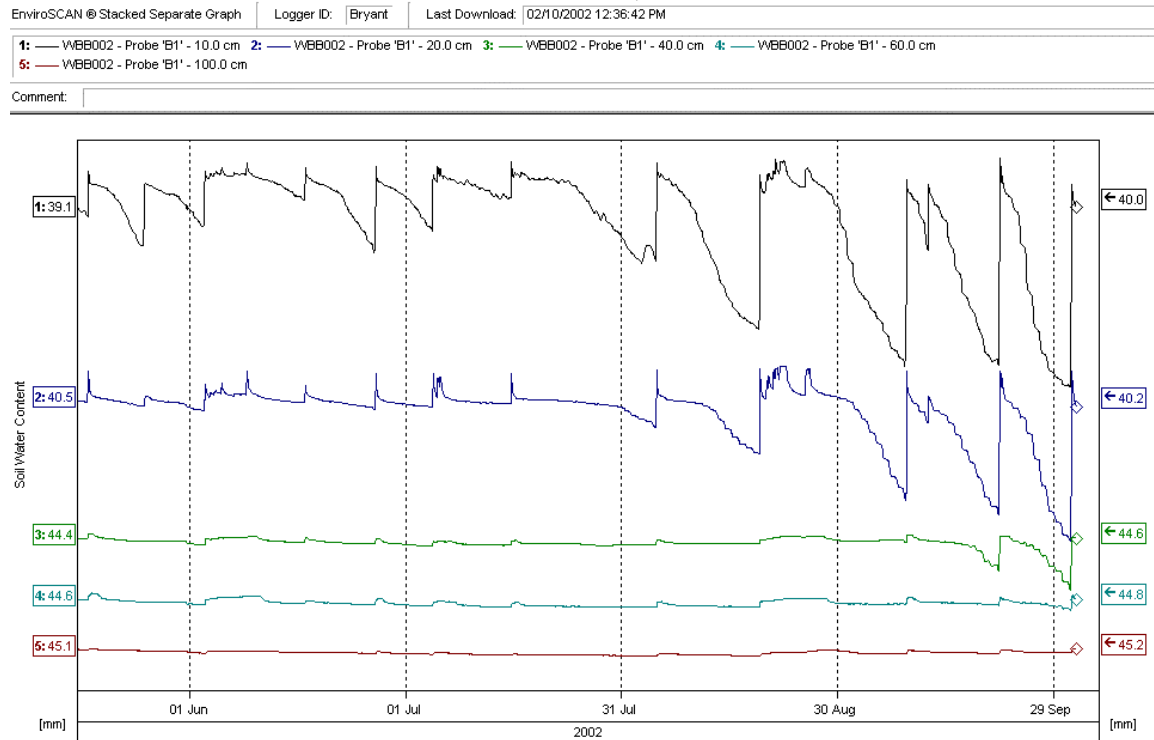
Farmer B –. See Enviroscan® graphs and automatic rain gauge chart attached The enviroscan graphs show that irrigation scheduling has been as close to crop requirements as possible, ensuring the soil moisture profile met crop demands. The predominant soil type near the enviroscan probe is clay loam.

The enviroscan graph shows that the crop was essentially working down to the root depth of 40cm. Excellent irrigation scheduling practices are being followed with the ryegrass not having to extract moisture from deep in the soil profile.

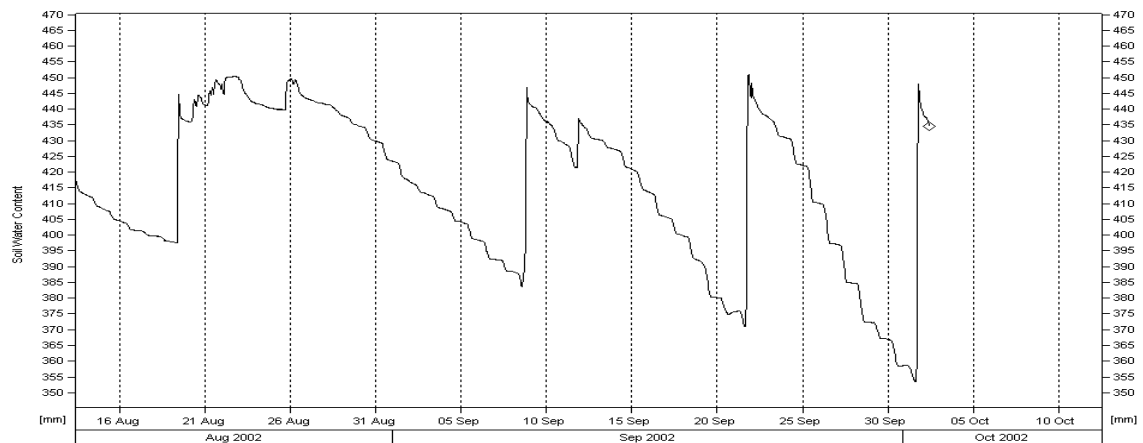
The graph below demonstrates that the soil moisture content is being maintained within a reasonably constant range.

EnviroSCAN @ Summed Graph - Interpolated    Logger ID: Bryant    Last Download: 02/10/2002 12:36:42 PM  
 Site ID's: WBB002  
 Probes: B1    Sensor Depth (cm): 10 + 20 + 40 + 60 + 100  
 Comment:

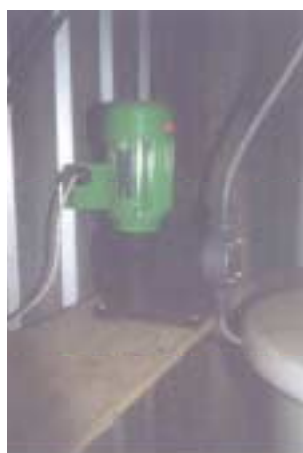
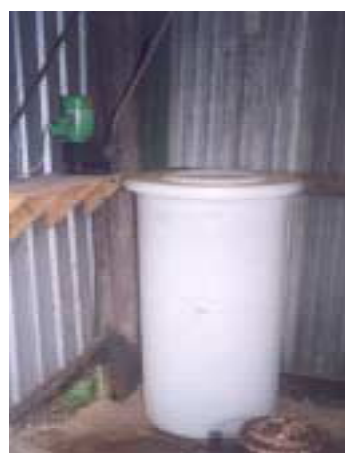
Set-up of fertigation equipment displaying pump and fertiliser mixing tank

The fine-tuning resulted in the replacement of the original 80 litre rectangular tank for mixing fertiliser to the larger 350-litre tank. This was enough for the 24 hour run.

They used 60 kg Urea in the 350-litre tank. The system applied 13.75 litres per hour over the 24 hour run with 20 litres left in the tank. The 24-hour run watered one hectare.

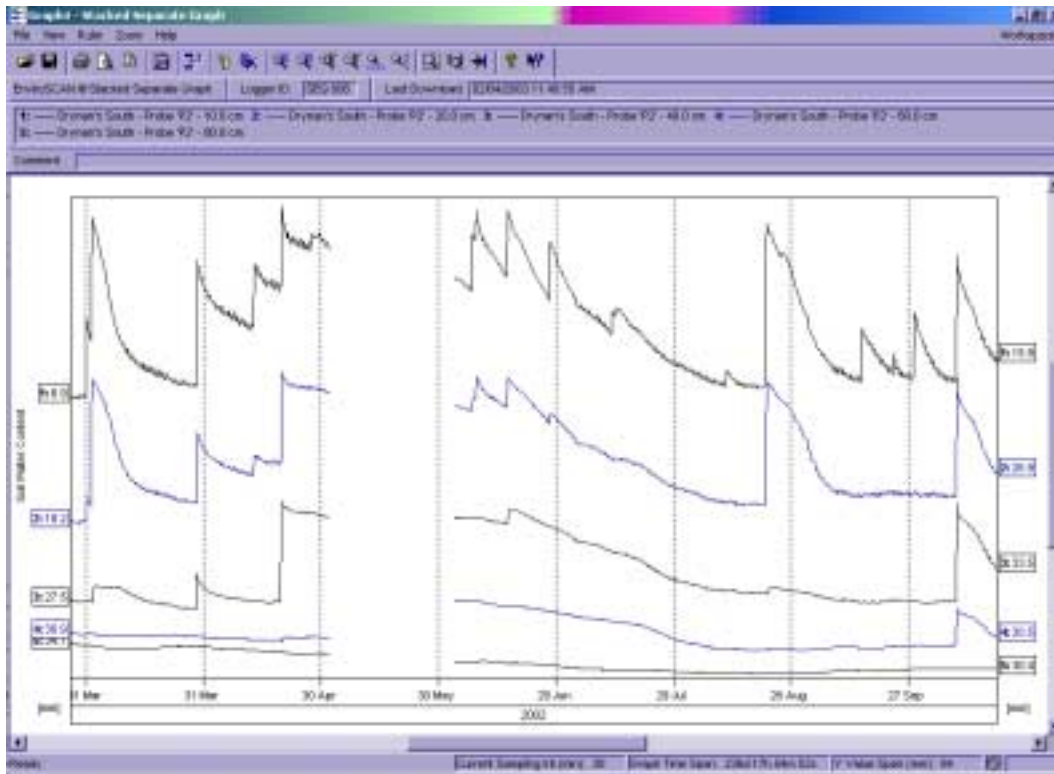
See graphs below. The Enviroscan® graphs show that irrigation scheduling has been sporadic, which is a result of the farmer having to irrigate when he has the water, not when it is the best time to irrigate. The data shows that soil moisture was not as high as the crop demands.

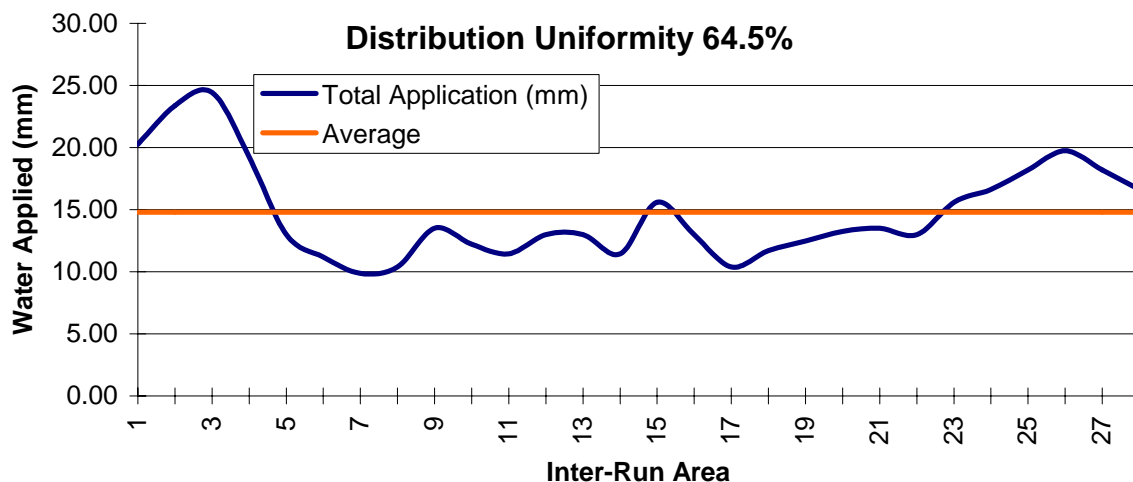
As can be seen the walker jets were applying a lot of water close to the irrigator carriage, however the rest of the paddock was receiving less than the average water application. Unfortunately due to financial restrictions and the impact of the drought, the farmer was unable to make any significant changes to the irrigation system. He did state “my neighbours crop is not growing evenly because the lane spacings are too far apart. You can actually see a wave effect across the paddock. This has become even more pronounced this season due to the effect of the drought”.

The farmer has learnt a lot on different aspects of irrigation since his involvement with the RWUE project. Originally he assumed that travelling gun irrigators naturally applied water evenly. He also thought that setting up the lane spacings according to manufacturers specifications would guarantee the water was applied evenly. However, after an irrigation system check he discovered that his system was not applying water as well as it should be. The irrigator was found to be running at 64.5% Distribution Uniformity.

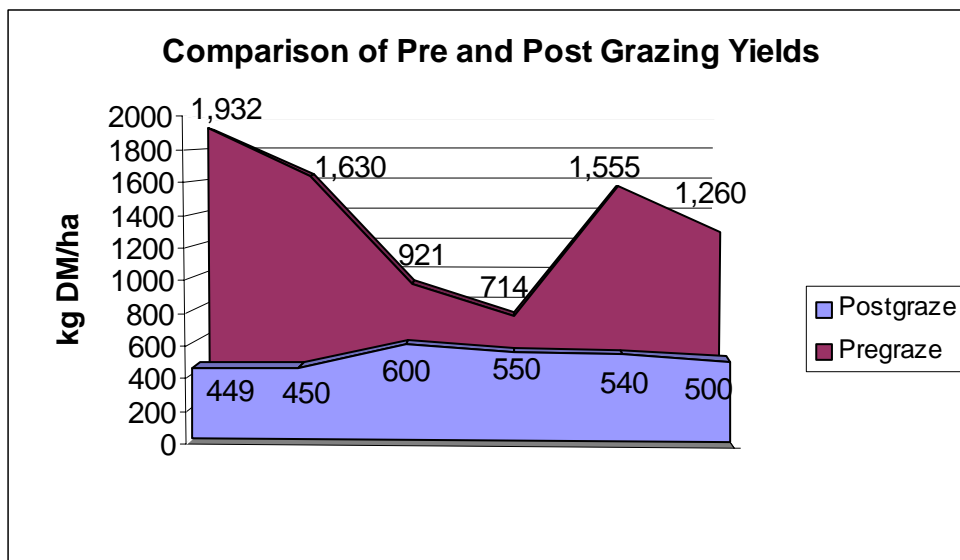
**Figure 1**

Figure 1 demonstrates the pre and post grazing pasture yields on the farm. These results are from the two paddocks which were monitored by the Enviroscan® probes.

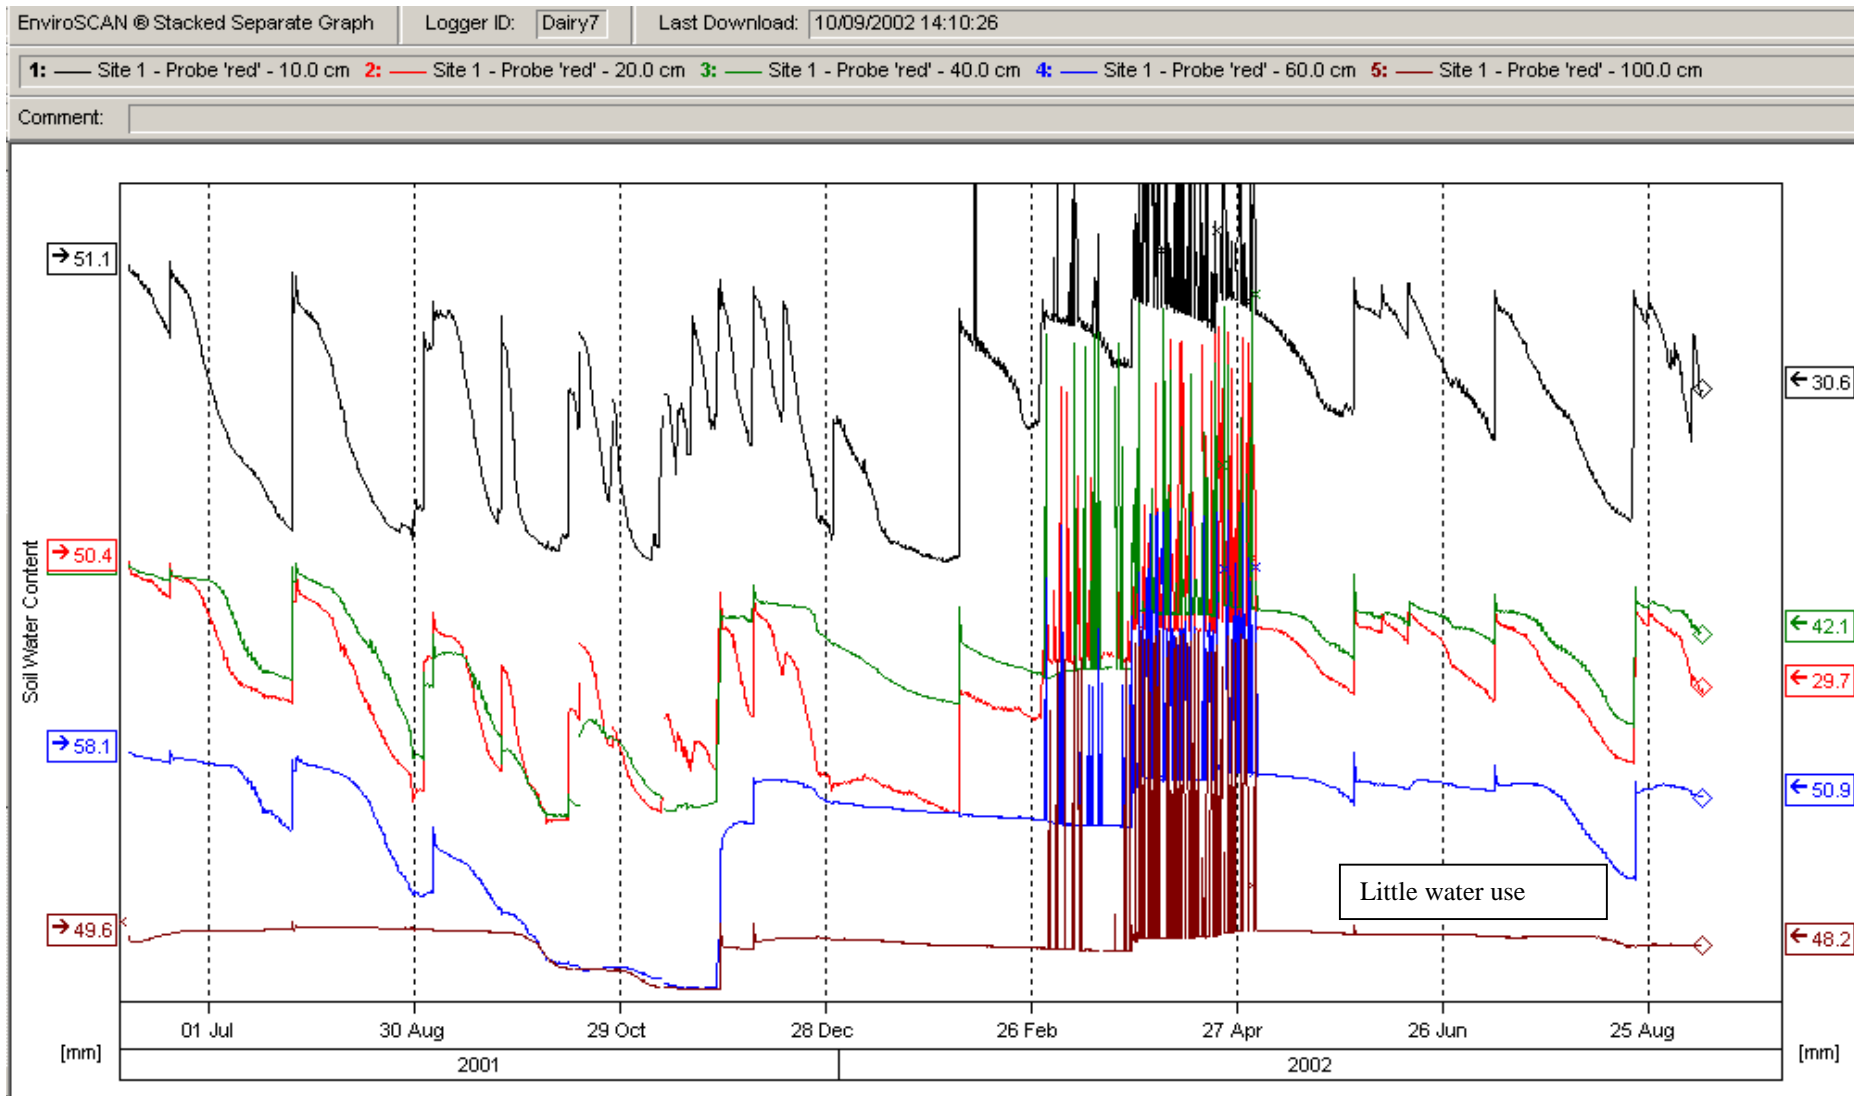
**Diagram 2 Stacked Graph; Lighter Red Soil - Lucerne**

The minimal change at the 100cm profile in the lighter reddish soil was most likely due to the fact that the lucerne was able to extract adequate moisture from the soil profile above (Diagram 2). Readily available water (RAW) accounts for a much higher percentage of plant available water (PAW) in lighter soils.

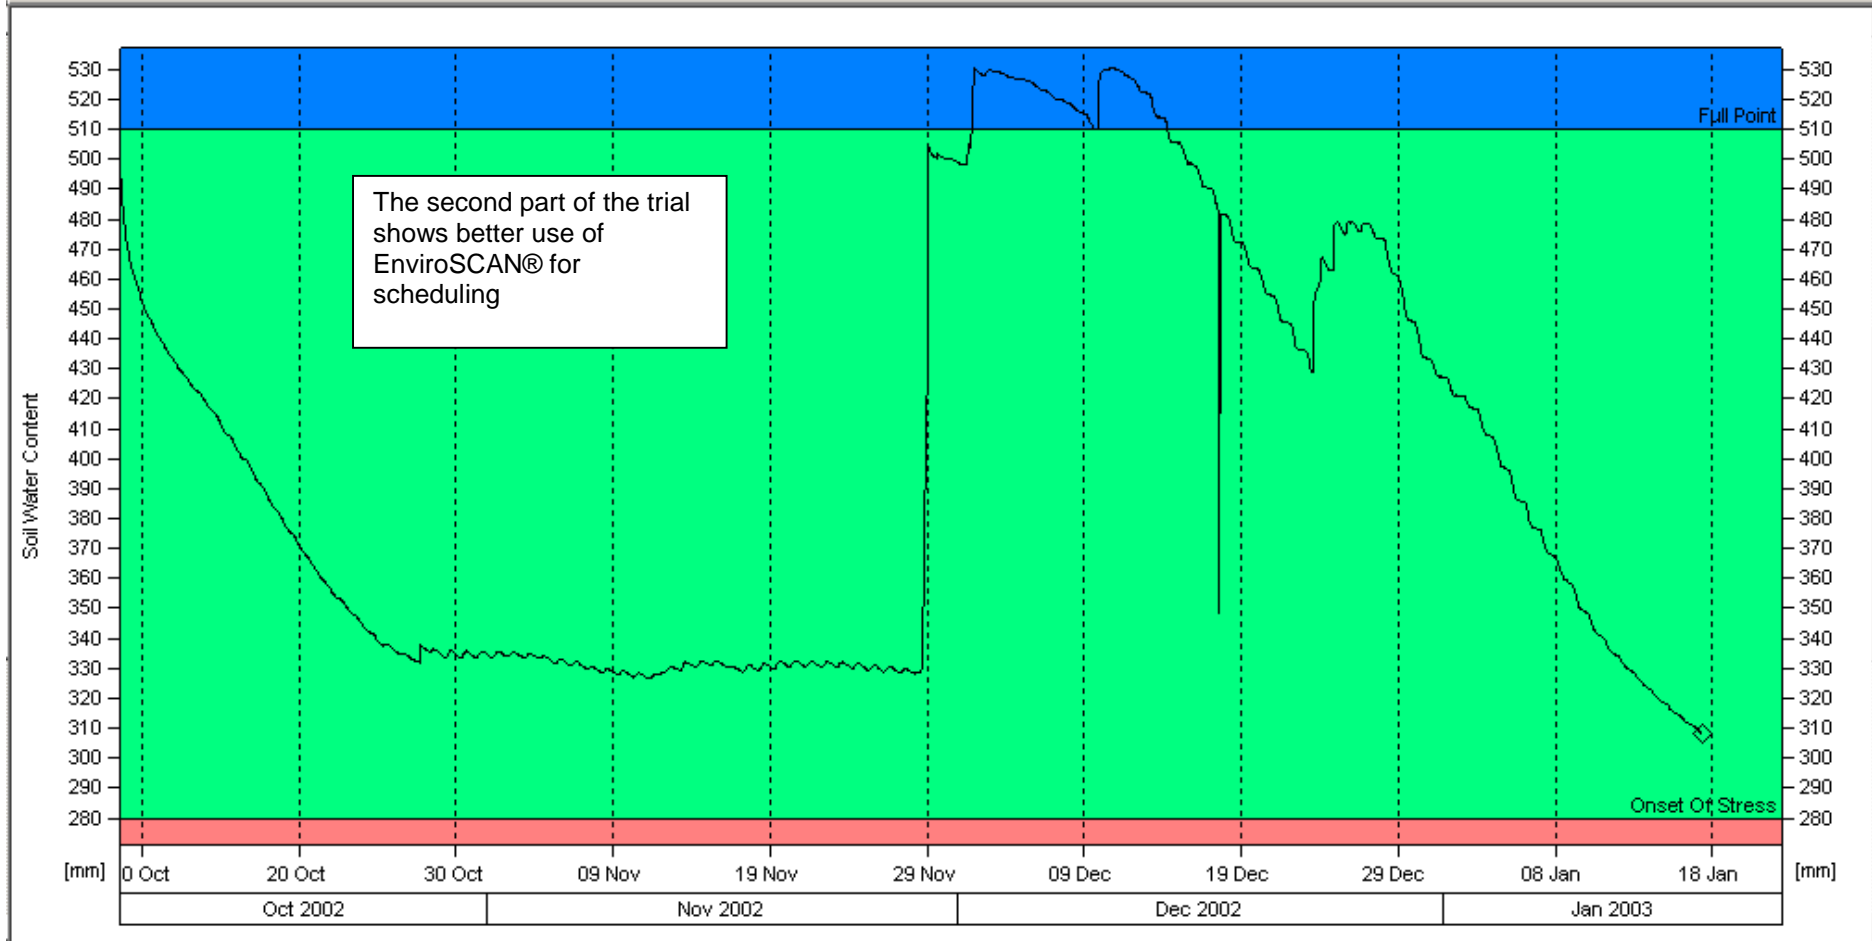
**Diagram 4 Summed Graph; Light Red Soil – Lucerne (part 2 of trial)**

EnviroSCAN® Summed Graph - Interpolated	Logger ID: Dairy 7	Last Download: 17/01/2003 13:33:59
Site ID's: Site 1		
Probes: P2	Sensor Depth (cm): 10 + 20 + 40 + 60 + 100	
Comment:

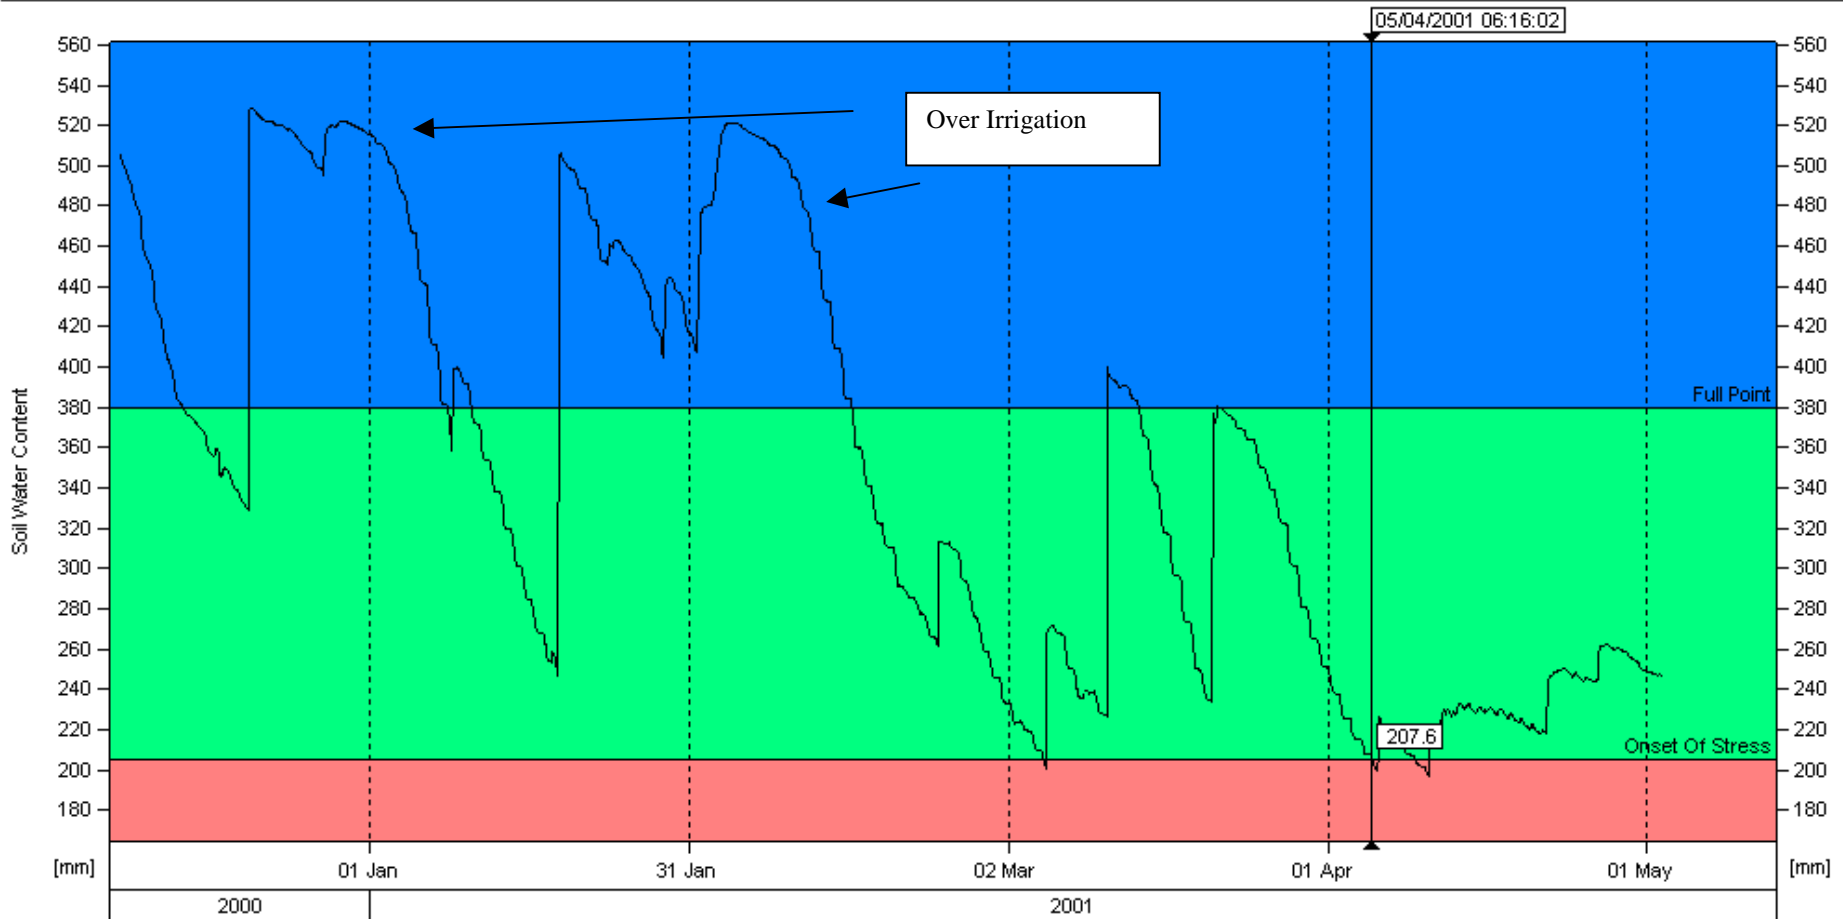
**Diagram 1 Summed Graph for Trial 1**

EnviroSCAN ® Summed Graph - Interpolated	Logger ID: Dairy6	Last Download: 22/01/2004 22:38:08
Site ID's: Site 1		
Probes: P2	Sensor Depth (cm): 10 + 30 + 60 + 100	
Comment:

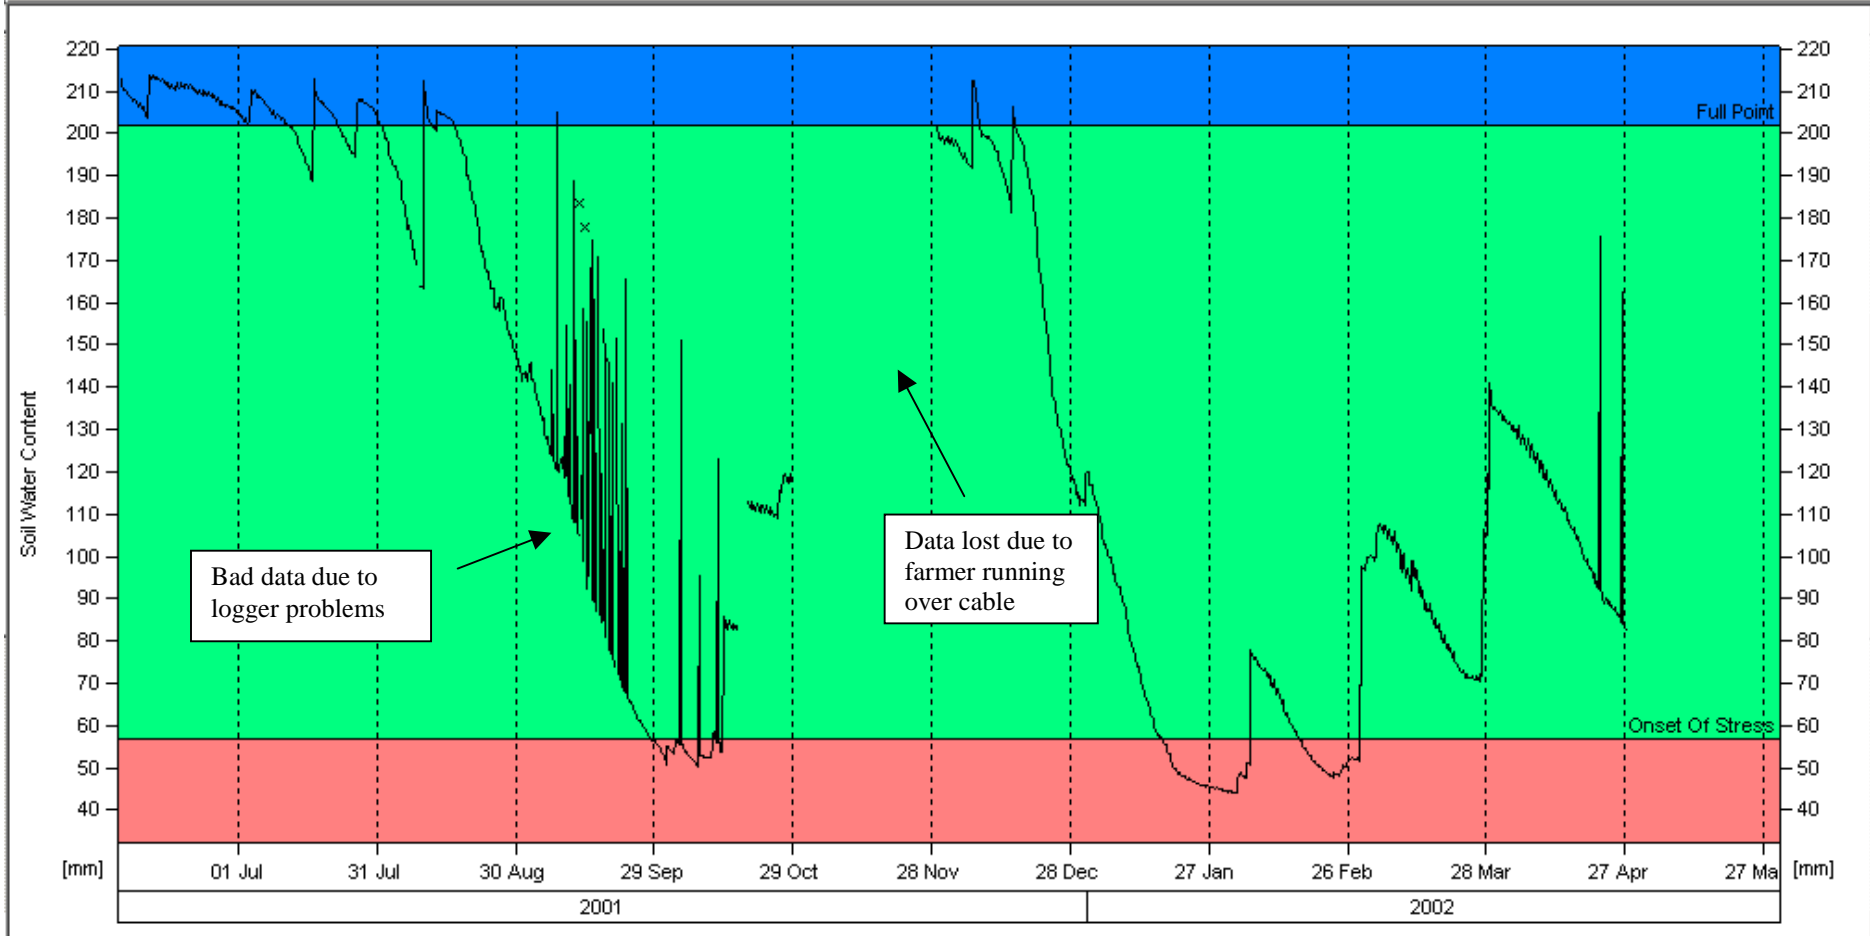
**Diagram 2 Summed Graph for Trial 2**

EnviroSCAN @ Summed Graph    Logger ID: Dairy6\_2    Last Download: 19/12/2002 10:45:04
