# Mackay Whitsunday Healthy Waterways

## Ambient Monitoring Program Regional Report 2008

## The ambient monitoring component of the Integrated Monitoring Program

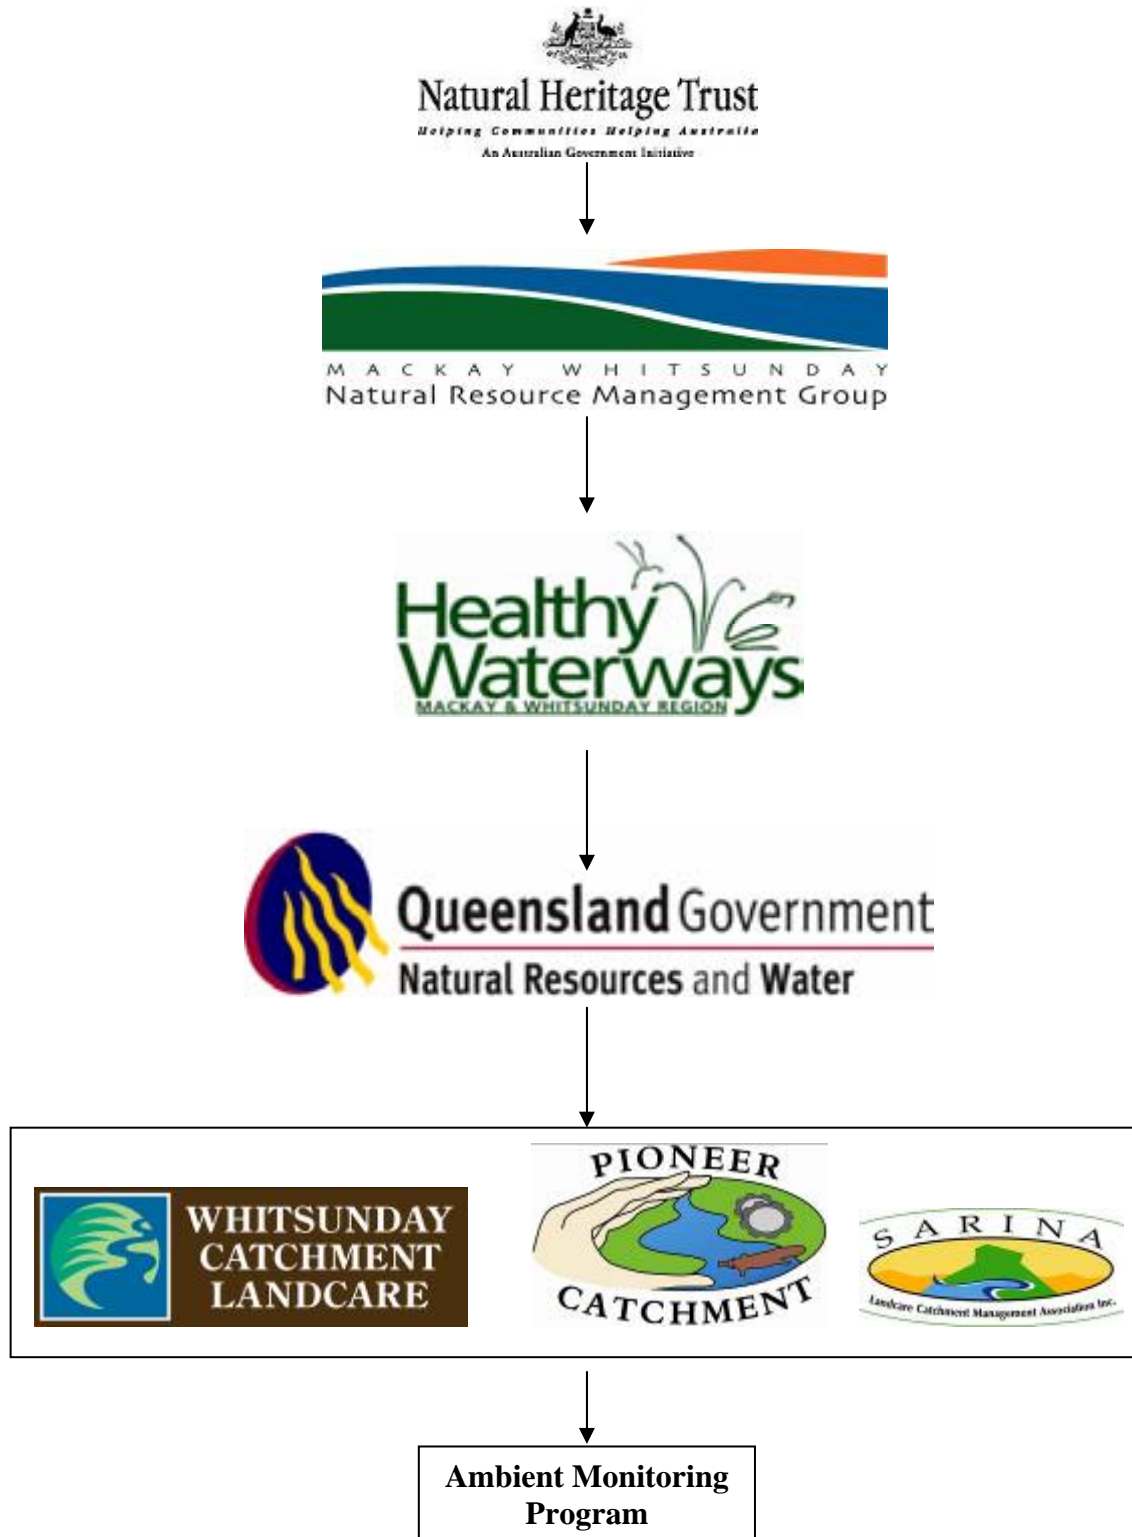
Figure 1 Mackay Whitsunday Healthy Waterways Integrated Monitoring Program Organisational Flow Chart

Funding for the Mackay Whitsunday Healthy Waterways Ambient Monitoring Program is provided by the Mackay Whitsunday Natural Resource Management Group. They are funded by the Natural Heritage Trust. Catchment project officers implement the program within the volunteer network and provide support to the NRW project officer (Figure 1).

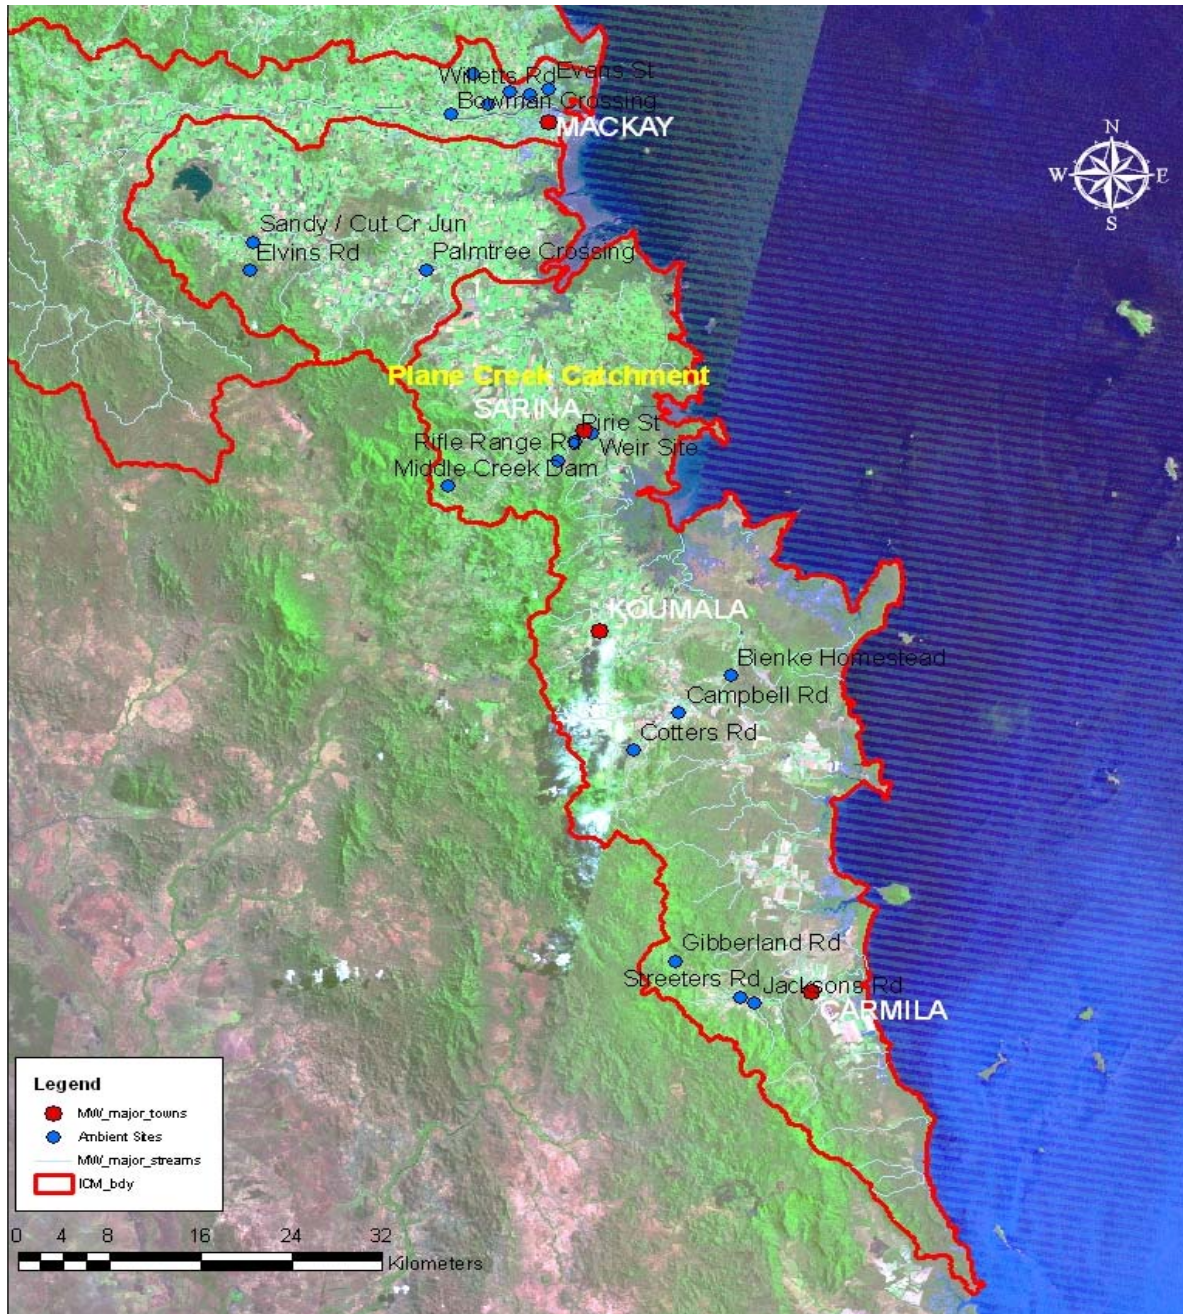
Figure 5 Healthy Waterways Ambient Monitoring Sites – Plane Creek Catchment

The Plane Catchment (Figure 5) (AWRC Basin 126) is bordered by Sandy Creek in the north, Clairview in the south and by the Connors Range in the west. Sugarcane dominates the northern part of the basin whereas cattle grazing dominates the southern part.

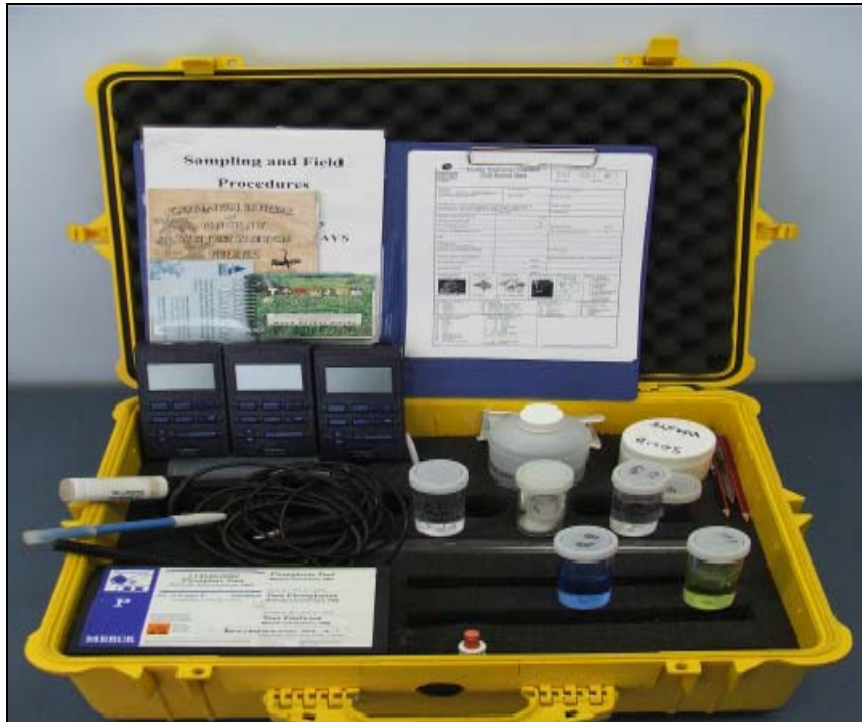
**Figure 6 Healthy Waterways Sampling Kit**

Dissolved oxygen, pH, electrical conductivity, filterable reactive phosphorus, clarity and water temperature are the ambient water quality parameters sampled monthly at each of the selected sites. A range of antecedent conditions including rainfall, water level, flow rate, water colour and presence of exotic floral specimens are also noted on the sampling trips. These trips commence at the same time of the day each month to ensure minimal variability which may be caused by sampling at different times throughout the day (Fries 2007b; Oldmeadow 2004). The volunteers are provided with a sampling kit by their catchment project officers (Figure 6). These kits contain reliable WTW water quality meters and probes as well as calibration solutions, turbidity tubes, data sheets, phosphate kit and all relevant instructions.

The volunteers use a bucket with a lanyard attached to collect the sample water. The bucket is triple rinsed with water from the site and the rinse water is discarded away from the sampling area to avoid contamination. The sample is taken from within the top 50 centimetres of the water column. After the sample has been collected, the volunteer relocates to a shaded area where the *in-situ* parameters are measured and recorded.

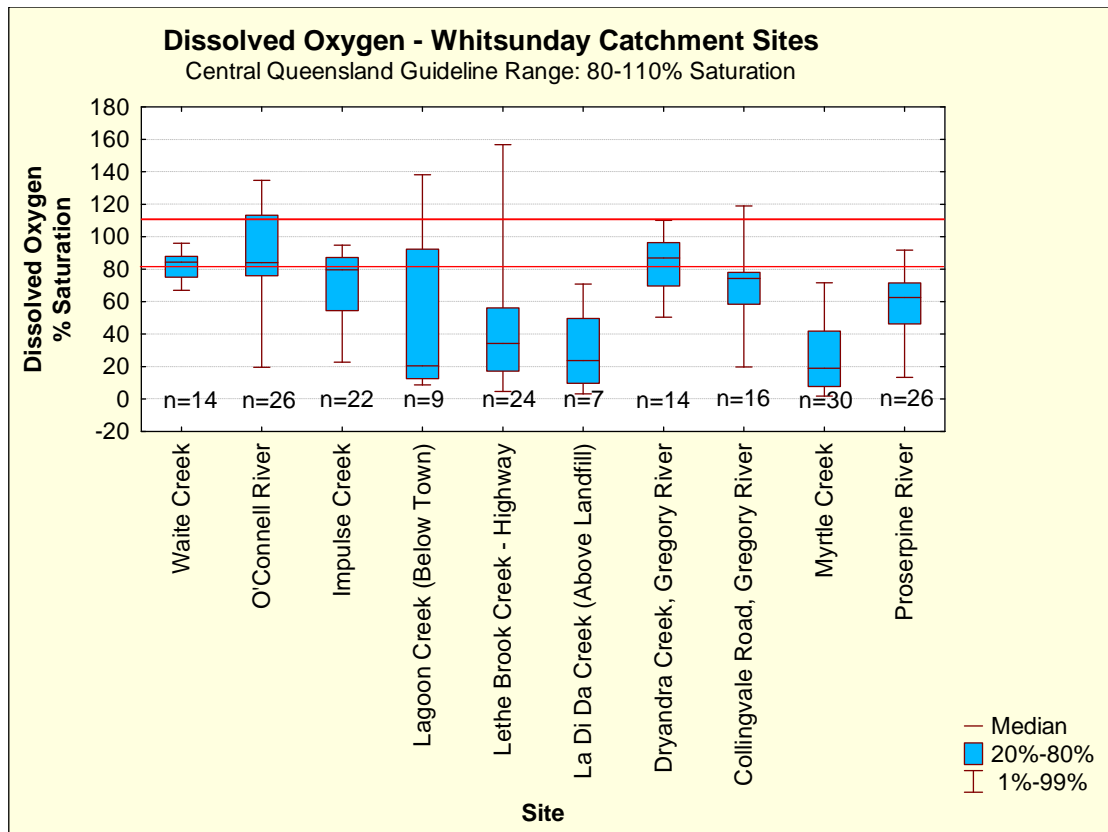
Figure 7 An example of a box and whisker plot (Dissolved oxygen – Whitsunday catchment sites)

Figure 7 is an example of a box and whisker plot which illustrates DO in the Whitsunday catchment. The “Myrtle Creek” site exhibits a minimum saturation value of 1.8 %, a maximum of 72 %, an 80<sup>th</sup> percentile value of 40 %, a median value of 19 % and a 20<sup>th</sup> percentile value of 7.2 % saturation. The site was sampled (n=) 30 times. The red lines indicate the central Queensland water quality guideline range for the parameter of dissolved oxygen. It should be noted that central Queensland water quality guideline values for water temperature and electrical conductivity do not exist at this stage.

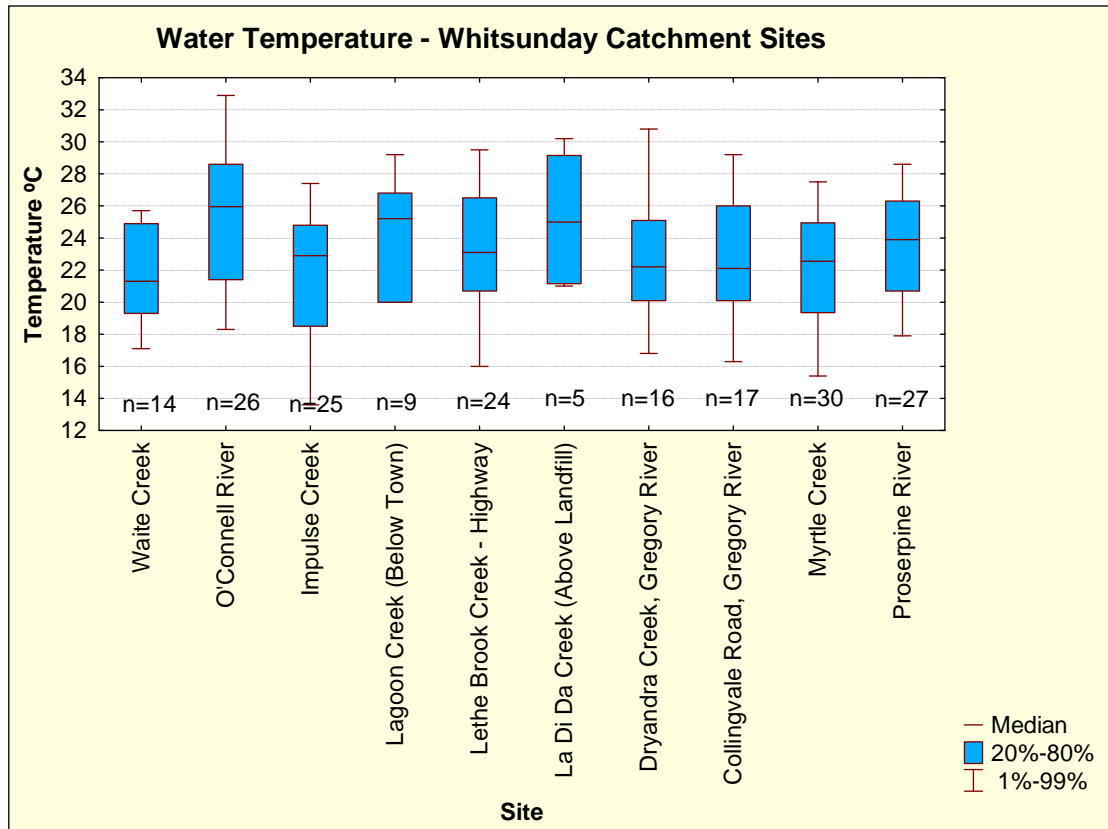
Figure 8 Water temperature – Whitsunday catchment sites

Relative uniformity was found between all sites in the Whitsunday catchment with median temperatures ranging from 21°C - 26°C, regardless of land use (Figure 8). The minimum temperature recorded was 13.8°C at Impulse Creek, a bushland site located in an elevated section in the headwaters of Conway National Park. It is a state reference site which discharges into Repulse Bay. Sites such as this naturally exhibit lower water temperatures due to their elevation. All sites in the Whitsunday catchment ranged from 18.4°C – 29.2°C on 80% of occasions. This range may seem large but given seasonal variation (fluctuations between summer and winter temperatures), it is relatively minor

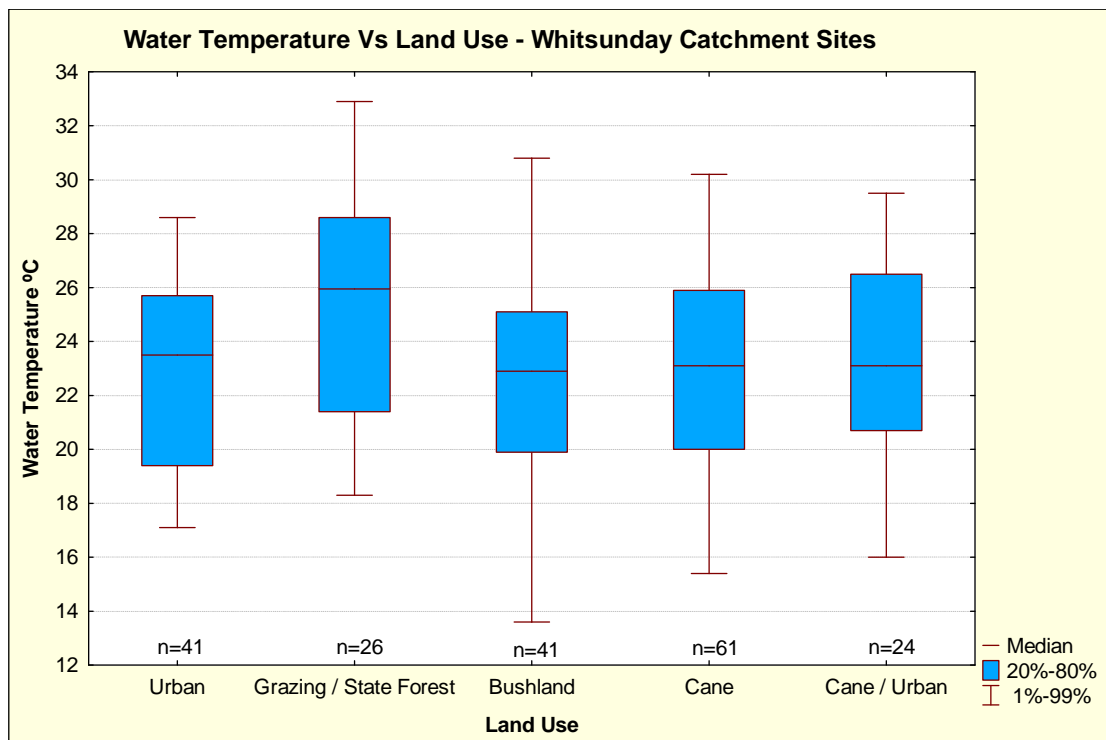
Figure 9 Water temperature Vs Land use – Whitsunday catchment sites

Once sites were grouped and categorised into their respective land uses, median temperatures ranged from 23°C – 26°C (Figure 9). Urban, bushland, cane and cane / urban sites portrayed median temperatures around 23°C with 80<sup>th</sup> percentile values of 25°C – 26°C. The grazing / state forest site (O’Connell River) was slightly higher with a median temperature of 26°C and 80<sup>th</sup> percentile of 28.5°C. This may be due to the fact that the O’Connell River has a large width and therefore able to retain more of the suns warmth.

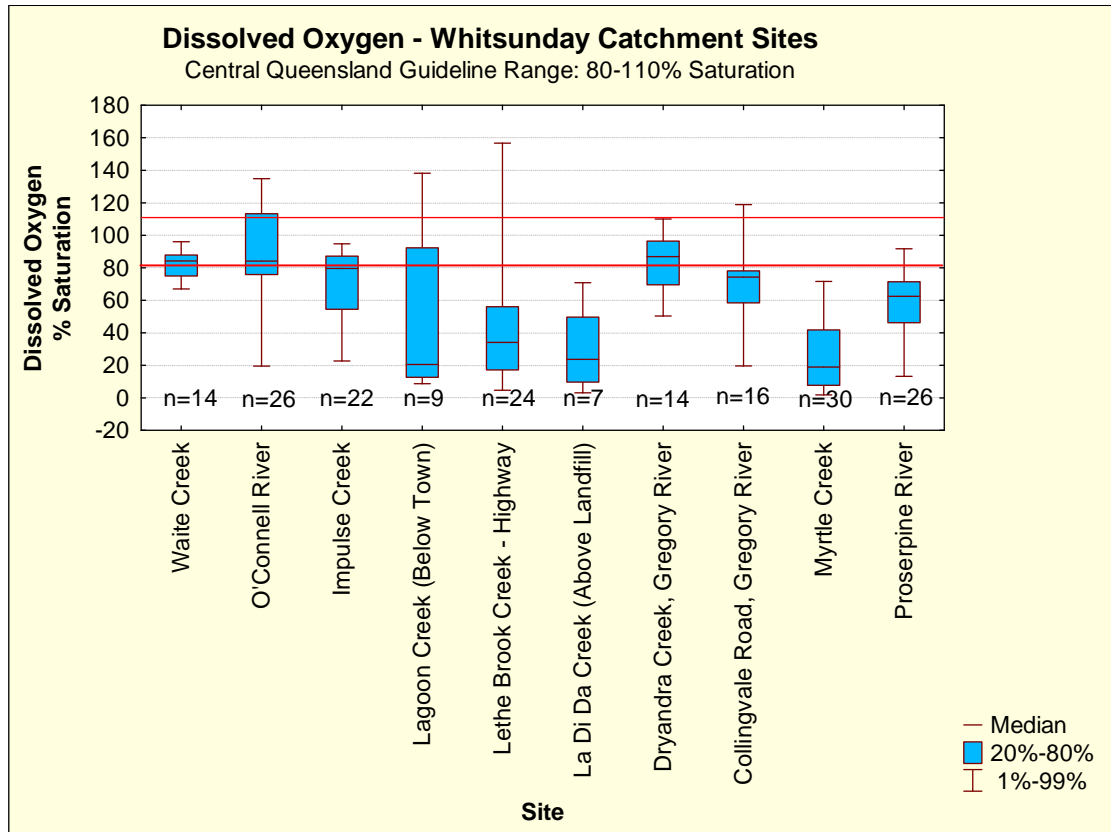
Figure 10 Dissolved oxygen – Whitsunday catchment sites

The Central Queensland water quality guideline for dissolved oxygen is 80% - 110% saturation. Great variability in dissolved oxygen concentrations were prevalent across all sites in the Whitsunday catchment. Waite Creek, O'Connell River, Impulse Creek and Dryandra Creek fell within this guideline range on 50% of occasions (Figure 10), however Waite Creek, O'Connell River and Dryandra Creek rated considerably better than Impulse Creek, which is a national park reference site. This result indicates that Impulse Creek exhibits naturally hypoxic conditions in comparison with bushland sites from other catchments. This may be due to the fact that this site is restricted to a shallow pool environment with abundant algal growth and no flow for the majority of the year.

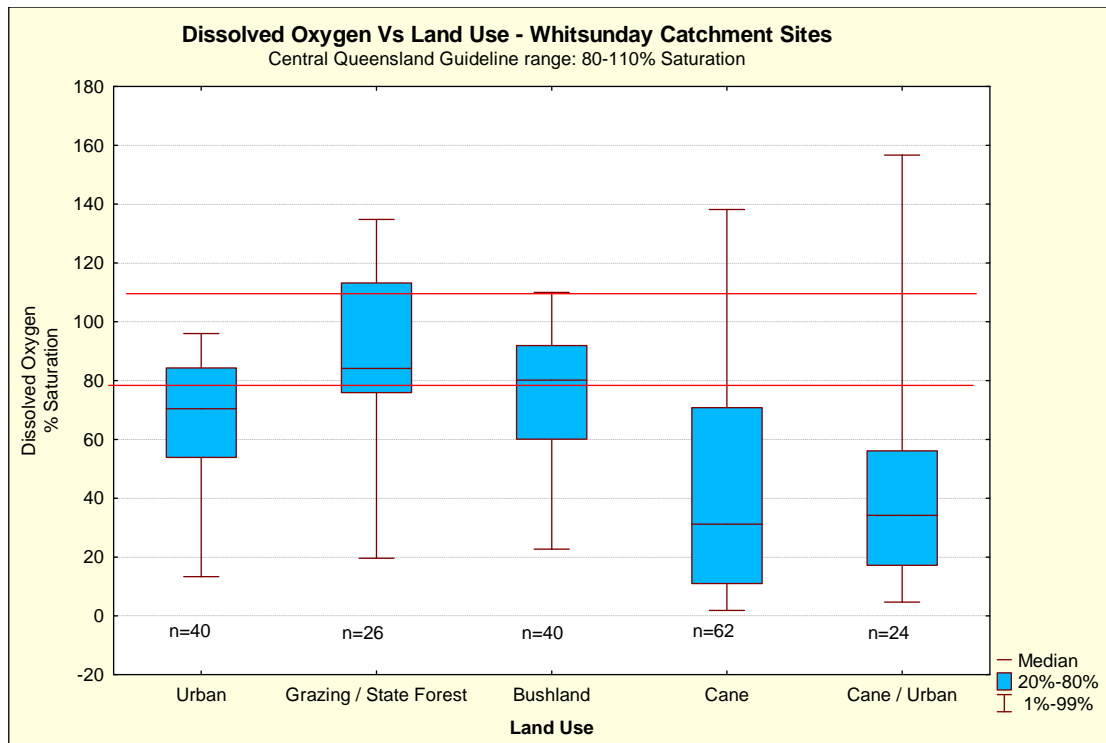
Figure 11 Dissolved oxygen Vs Land use – Whitsunday catchment sites

Grazing / State forest, as well as bushland sites, fell within the central Queensland guideline range on 50% of occasions (Figure 11). The grazing / state forest site (O’Connell River) has higher oxygen concentrations than the Impulse Creek site. Once again this shows that Impulse creek may be oxygen deficient in comparison to other bushland sites.

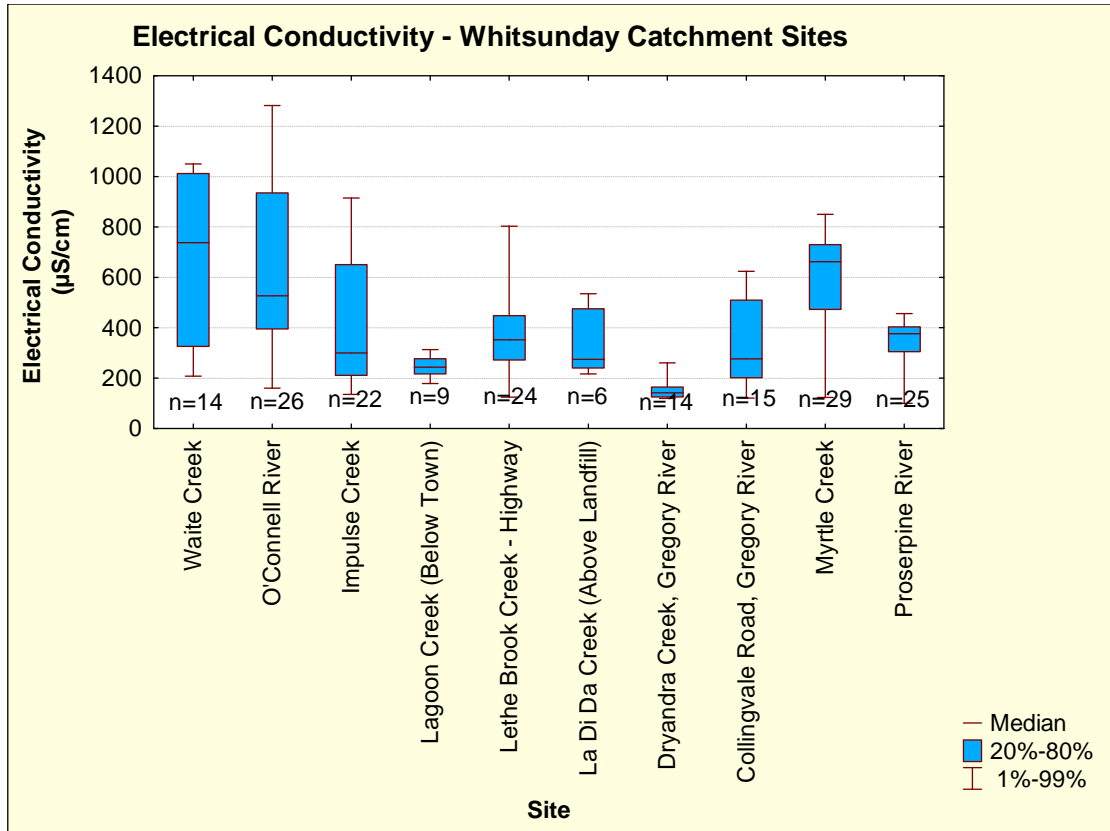
Figure 12 Electrical conductivity – Whitsunday catchment sites

The O’Connell River exhibits the greatest range (180  $\mu\text{S}/\text{cm}$  – 1300  $\mu\text{S}/\text{cm}$ ). The sampling site is at the caravan park which is located in a tidally influenced area.

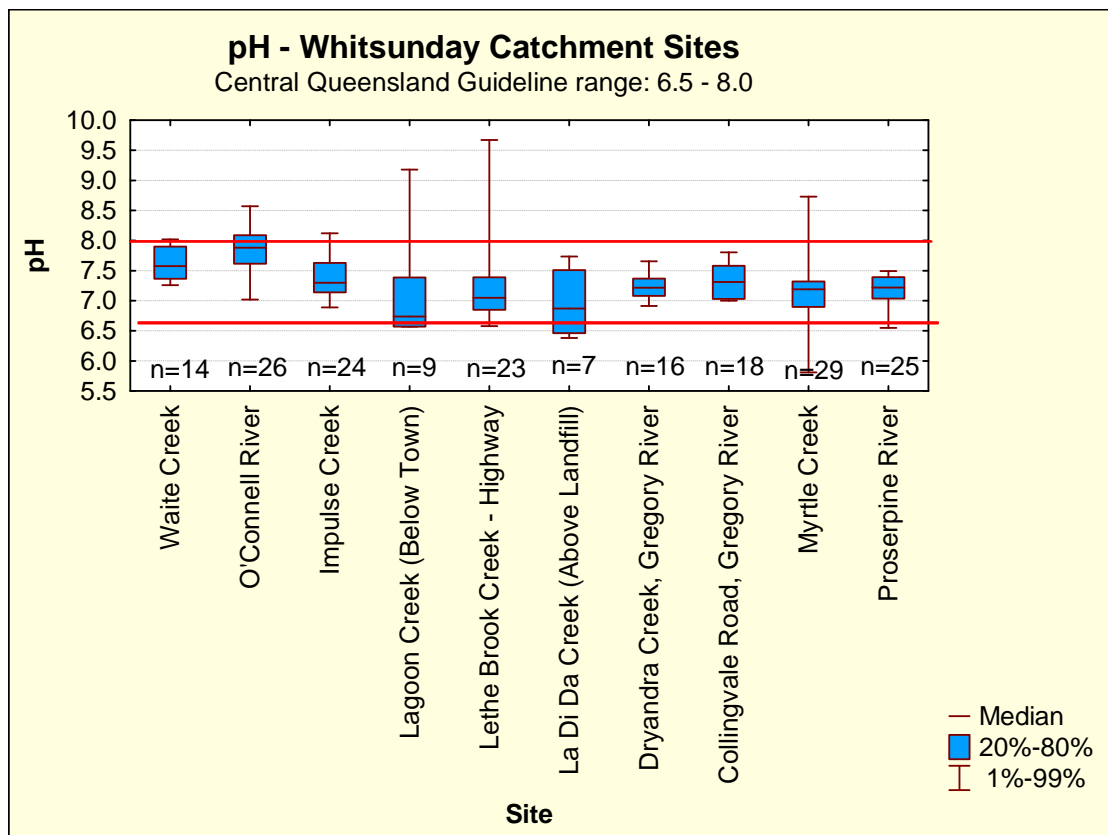
Figure 14 pH – Whitsunday catchment sites

### 5.1.4 pH

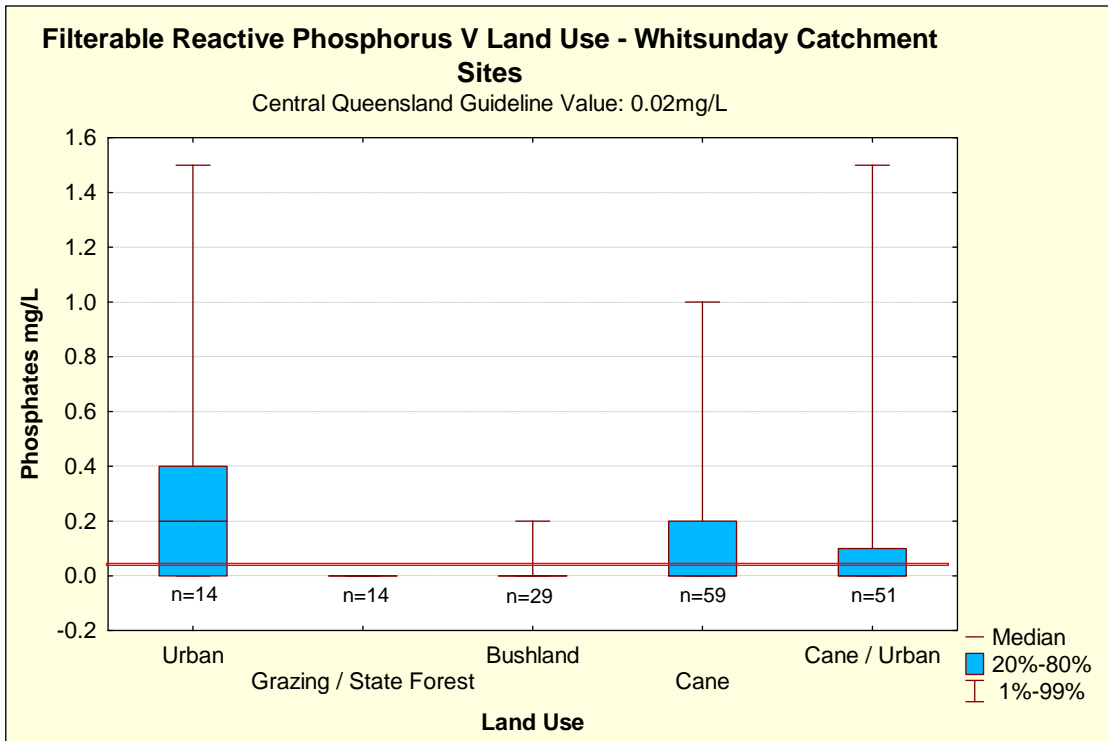
Figure 17 Filterable reactive phosphorus Vs Land use – Whitsunday catchment sites

Urban, cane and cane / urban sites were definitely the land uses of concern with levels of 1 – 1.5 mg/L at certain times of the year (Figure 17). Fertiliser in runoff from cane dominated catchments, and urban stormwater runoff are the likely reasons for these high FRP concentrations.

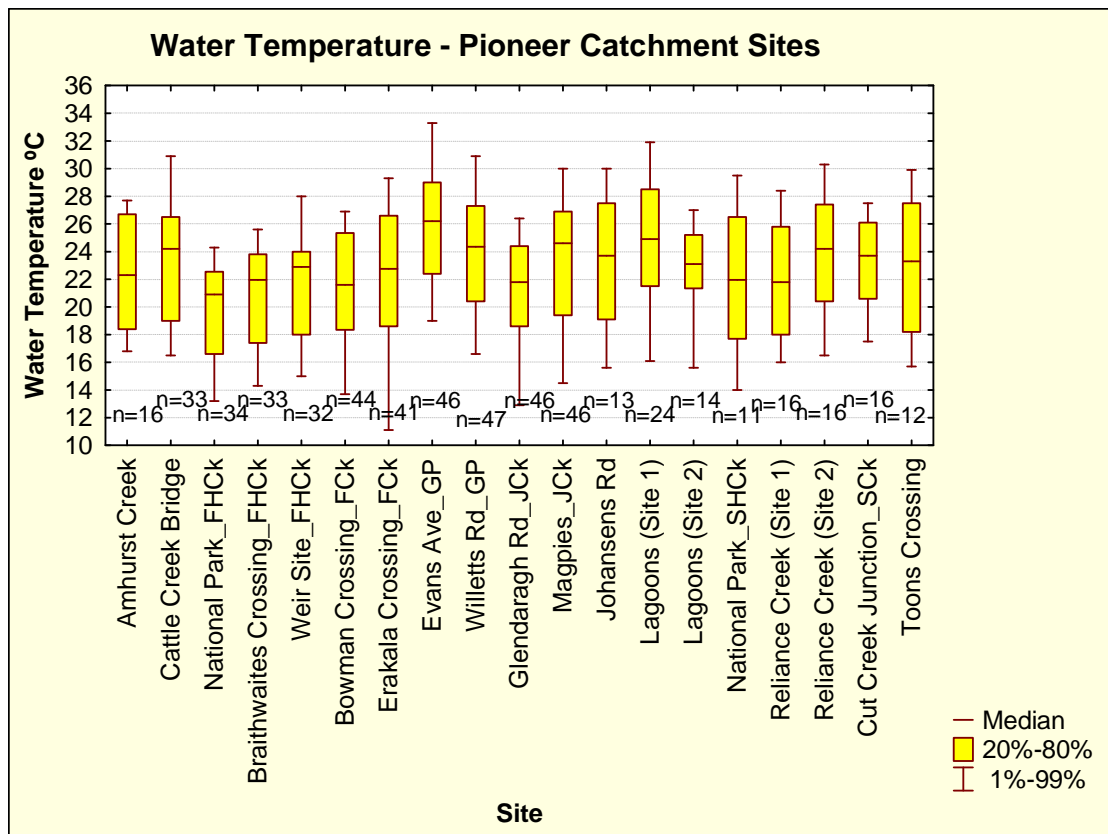
**Figure 21 Water temperature – Pioneer catchment sites**

Urban sites (Willets Road and Evans Avenue) portrayed the highest temperatures which were just below 26°C on 50% of occasions. The poor state of the riparian vegetation at these sites may attribute to these elevated water temperatures.

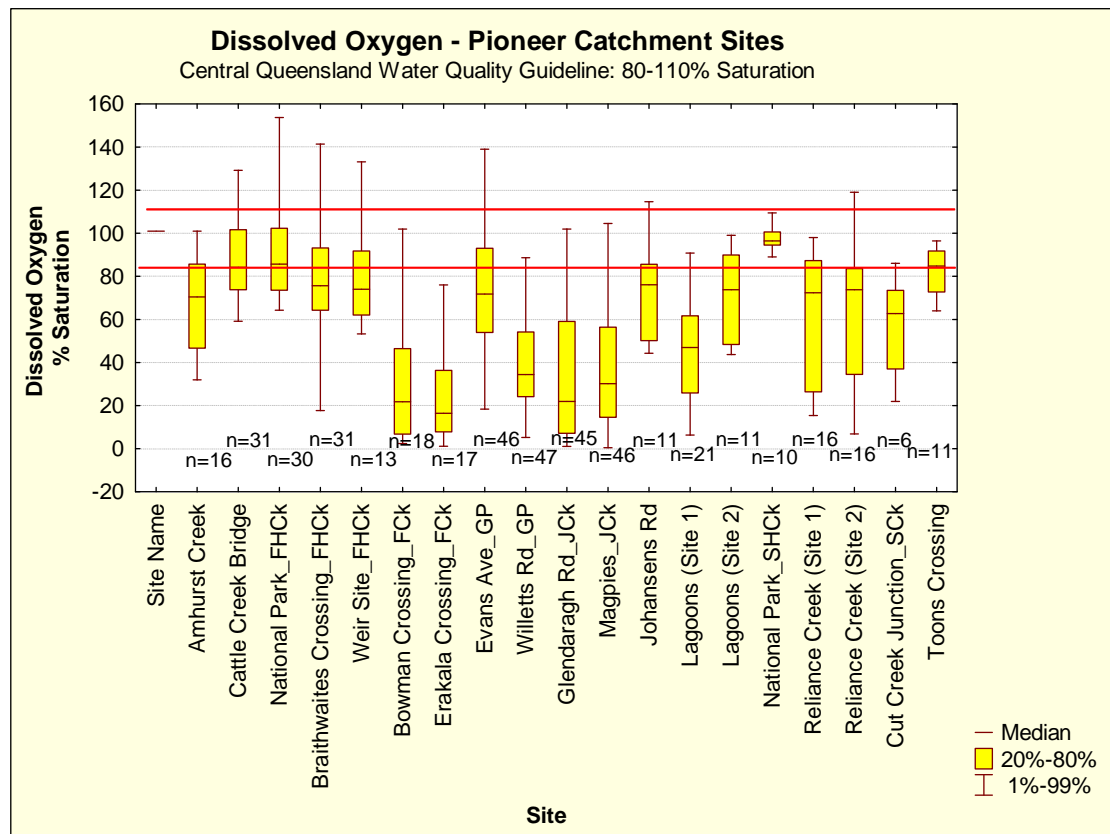
**Figure 23 Dissolved oxygen – Pioneer catchment sites**  
 (Note: FHCK – Finch Hatton Creek; FCK – Fursden Creek; GP – Gooseponds; JCK – Janes Creek; SHCK – St Helens Creek; SCK – Sandy Creek)

Bowmans Crossing (Fursden Creek), Erakala Crossing (Fursden Creek) and Glendaragh Road (Janes Creek) exhibited very poor results (around 20% saturation for 50% of occasions). These sites are located in areas where sugar cane farming dominates the primary land use. Low DO concentrations such as these are deemed hypoxic and are detrimental to life within an aquatic ecosystem. Fursden Creek is considered an important nursery ground for fish species such as Barramundi and Mangrove Jack. Hypoxic conditions limits the ability of these important recreational fish species to successfully colonise these areas. Fish may suffer acute asphyxiation when dissolved oxygen levels fall below 25% saturation (Faithful 2003).

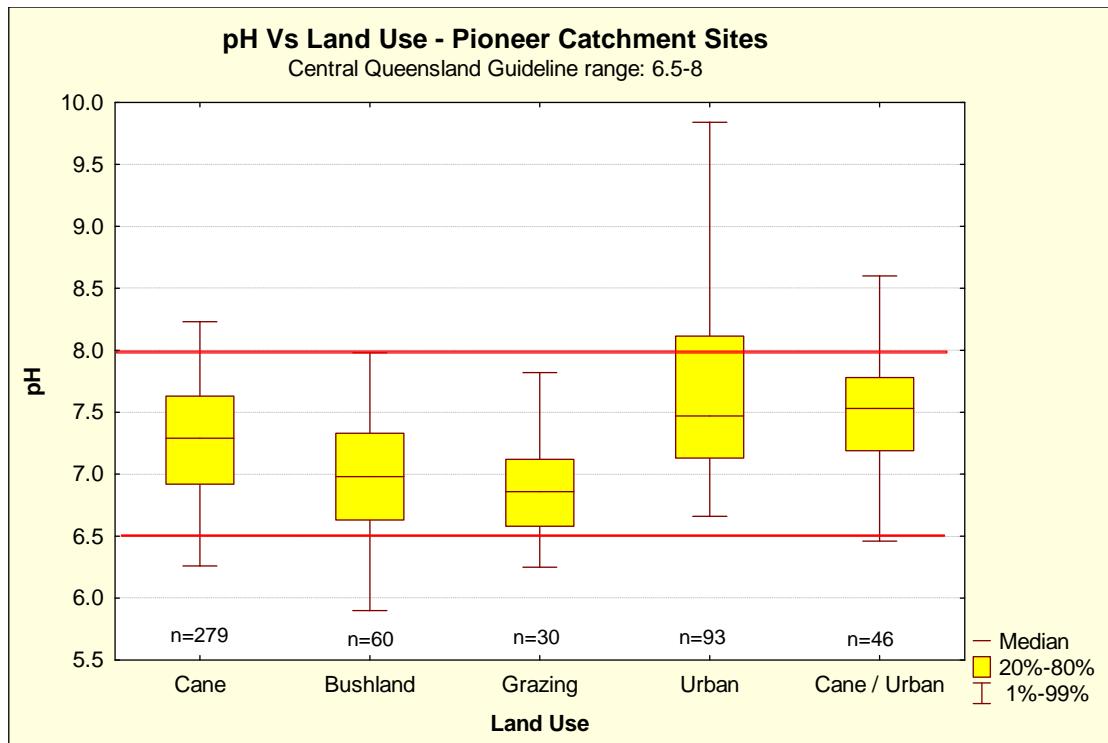
Figure 28 pH Vs Land use – Pioneer catchment sites

Bushland sites had the lowest minimum pH values with readings around 5.9 on occasions (Figure 28). This may be due to the lithology of Finch Hatton Creek and St Helens Creek.

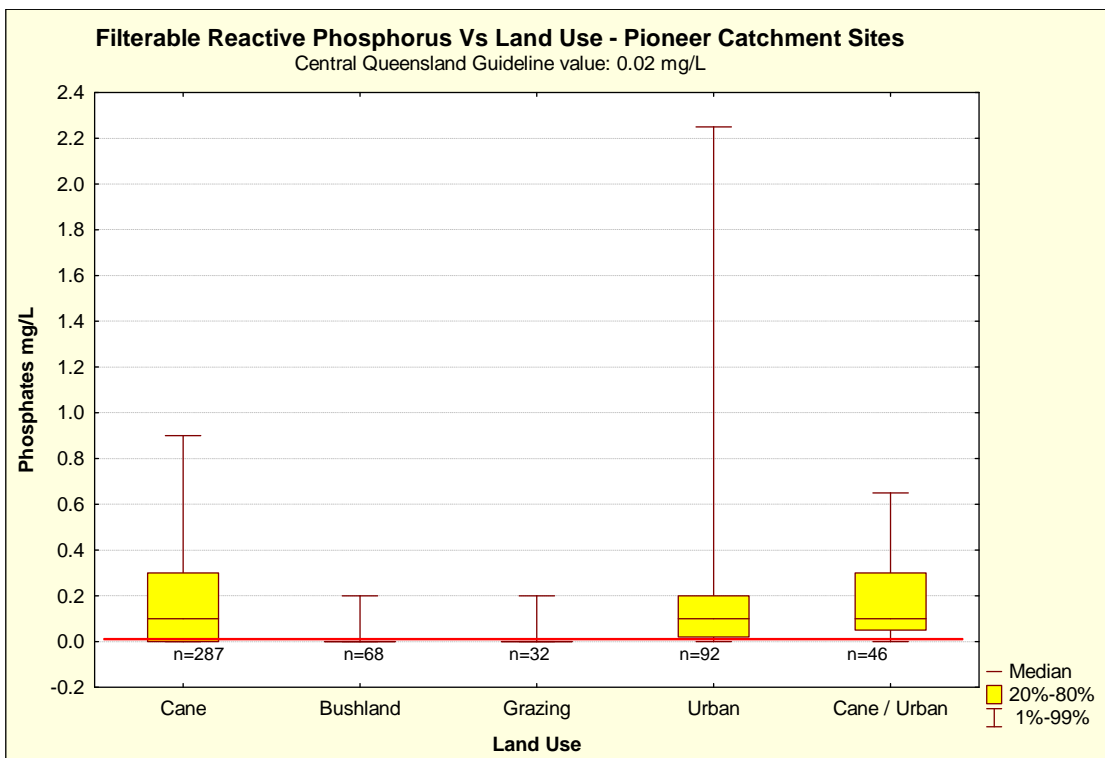
**Figure 30 Filterable reactive phosphorus Vs Land use – Pioneer catchment sites**

Urban dominated sites exhibited large maximum FRP levels after rainfall (Figure 30). This indicates the need for adequate storm water runoff measures to decrease organic matter, pollutants and sediment entering the aquatic ecosystem

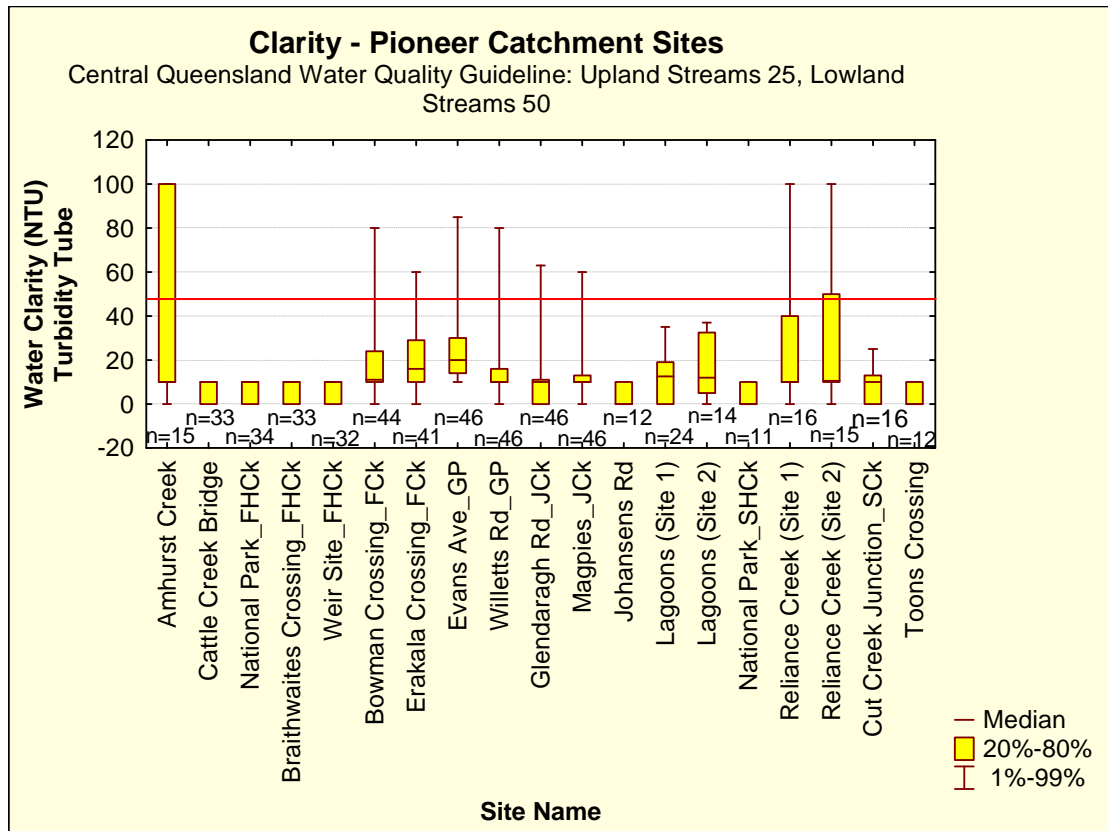
**Figure 31 Clarity – Pioneer catchment sites**  
 (Note: FHCK – Finch Hatton Creek; FCK – Fursden Creek; GP – Gooseponds; JCK – Janes Creek; SHCK – St Helens Creek; SCK – Sandy Creek)

Amhurst Creek exhibits very poor clarity (100 NTU on 80% of occasions). The number of samples (15) indicates that this site has been sampled all through the year, so one off event sampling for this location can be ruled out as the likely cause for this poor clarity. This site is located downstream of Farleigh Mill which releases mill water and effluent into the creek.

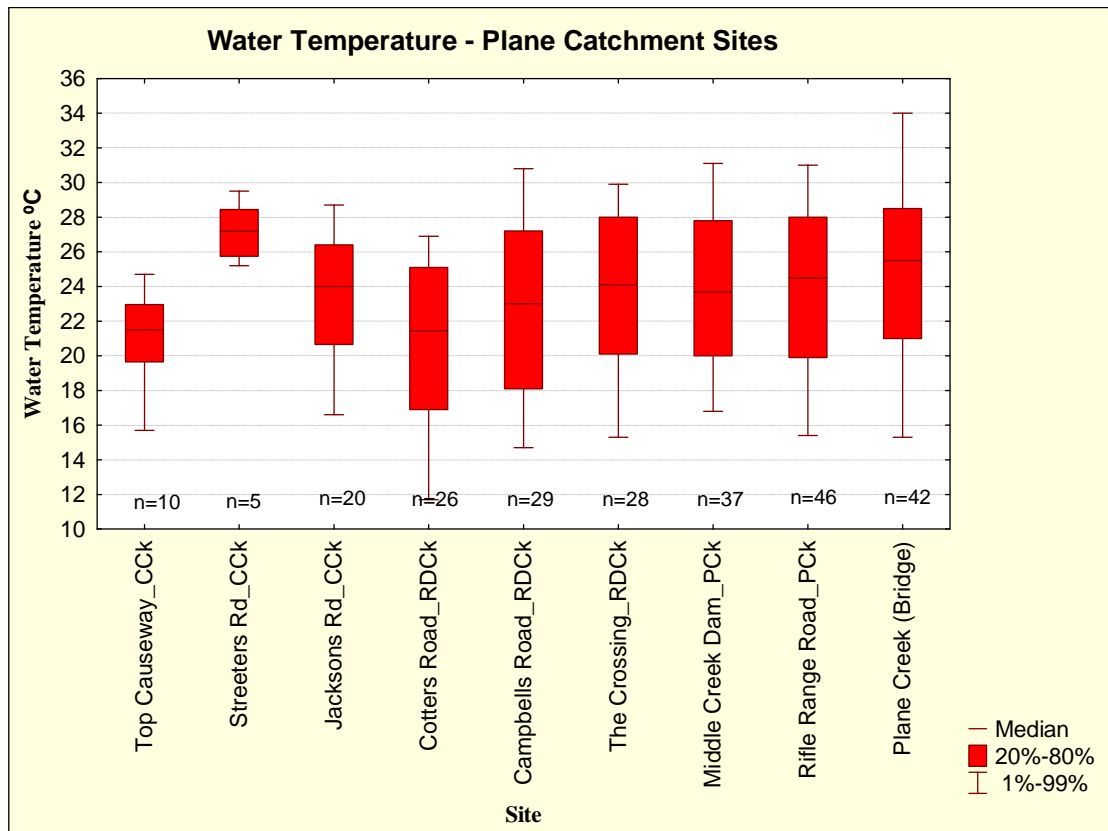
**Figure 33 Water temperature – Plane catchment sites**  
 (Note: Cck – Carmila Creek; RDck – Rocky Dam Creek; PCk – Plane Creek)

The Streeters Road site on Carmila Creek had the least variation with a range of 25.2 – 29.5°C. Its median temperature of 27.1°C is slightly higher than the median temperatures of other sites. This result may be potentially misleading due to the fact that this site had only been sampled 5 times (hence the low variability shown in the box plot) with samples taken from October 2005 to February 2006. These are the warmer months of the year and will account for the higher median temperature.

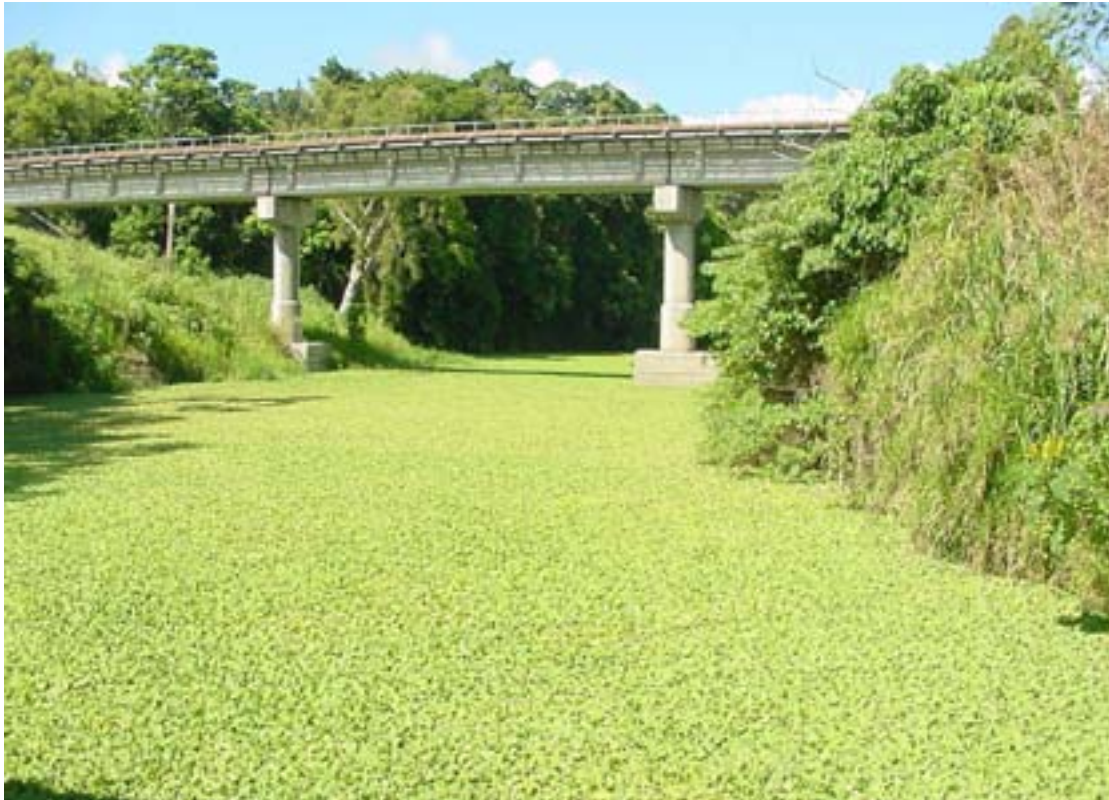
**Figure 35 Water Lettuce bloom – Plane Creek at Sarina**

Jacksons Road (Carmila Creek), Campbells Road (Rocky Dam Creek), Middle Creek Dam (Plane Creek) and Plane Creek Bridge all possessed extremely low minimum oxygen levels ranging from 4.4 – 10.5% saturation. Hypoxic conditions such as these would make these sites inhospitable to the substantial majority of higher order aquatic species for periods of the year. These low oxygen levels occurred during an outbreak of the exotic weed - Water Lettuce (Figure 35). Limiting the amount of nutrient-laden runoff from neighbouring cane farms would help reduce the incidence of such unpleasant weed outbreaks.

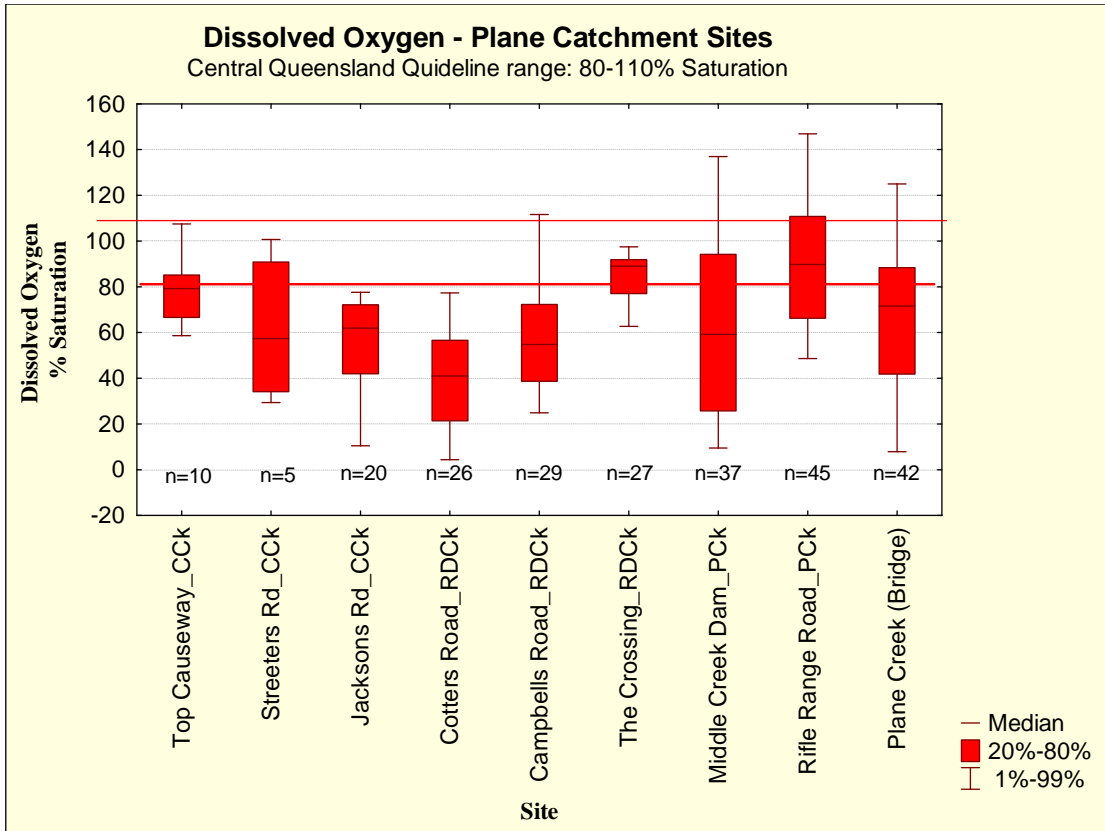
**Figure 36 Dissolved oxygen – Plane catchment sites**  
(Note: CCK – Carmila Creek; RDCK – Rocky Dam Creek; PCK – Plane Creek)

Top Causeway (Carmila Creek), The Crossing (Rocky Dam Creek) and Rifle Range Road (Plane Creek) reached the minimum guideline value of 80% saturation, half the time. The median dissolved oxygen concentrations for all sites in the Plane catchment ranged from 40 – 88% saturation (Figure 36).

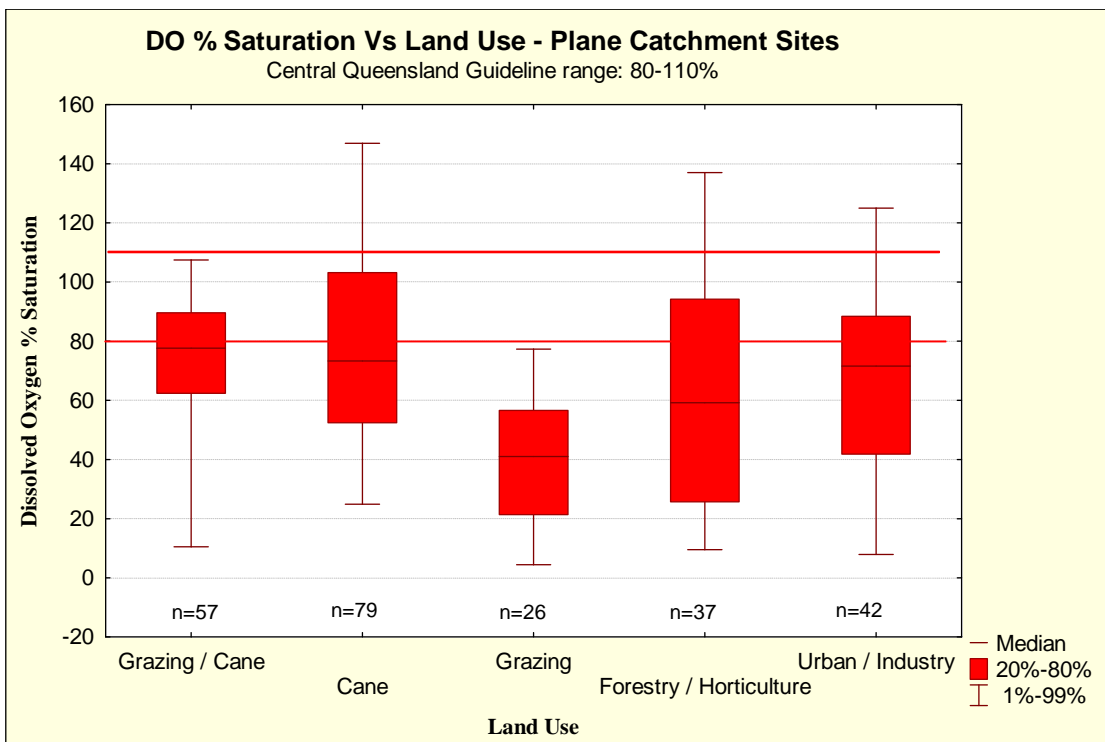
**Figure 37 Dissolved oxygen Vs Land use – Plane catchment sites**

Grazing / cane catchments reached the minimum guideline of 80% saturation on half the sampling occasions. Cane catchments reached 74% saturation for half of the time (Figure 37). This illustrates that grazing / cane and cane-dominated catchments in the Plane Creek catchment were no-where near as oxygen deficient as similar land uses in the Whitsunday and Pioneer catchments.

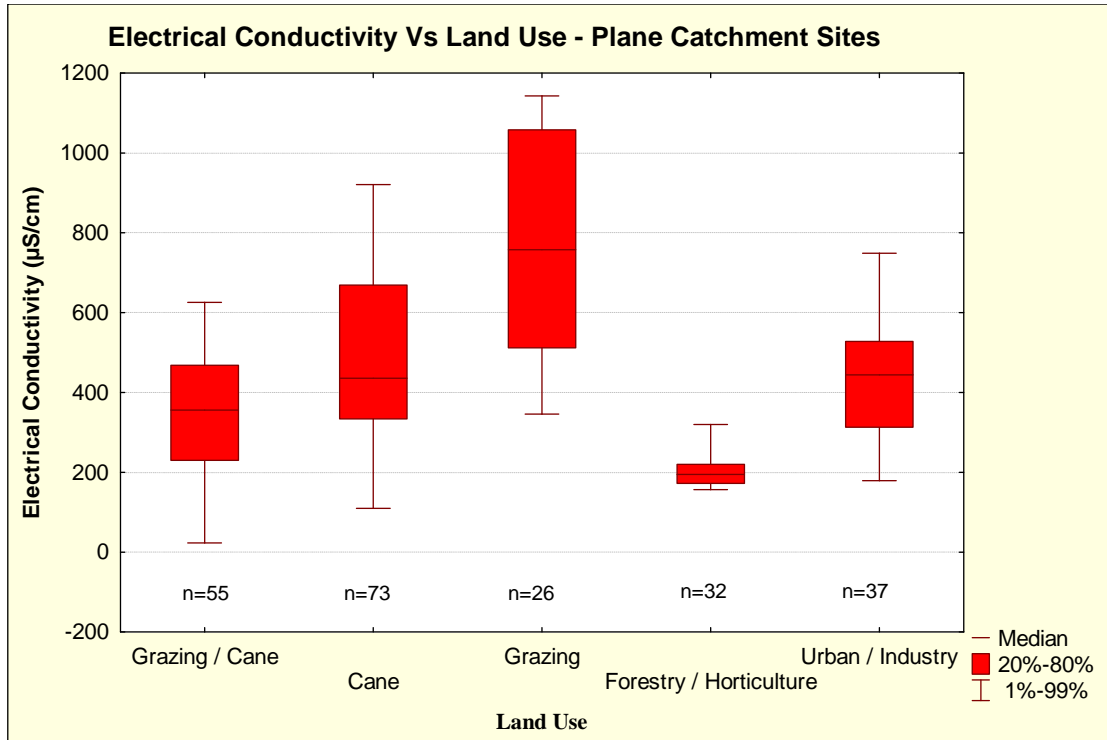
Figure 39 Electrical conductivity Vs Land use – Plane catchment sites

Grazing / cane, cane and urban / industrial sites gave similar medians (350 – 450  $\mu\text{S}/\text{cm}$ ), but variable minima and maxima (Figure 39). EC readings at these 3 sites were higher early in the summer months and lower after the wet season.
