# Mackay Whitsunday Healthy Waterways

## Ambient Monitoring Program Regional Report 2008

## The ambient monitoring component of the Integrated Monitoring Program

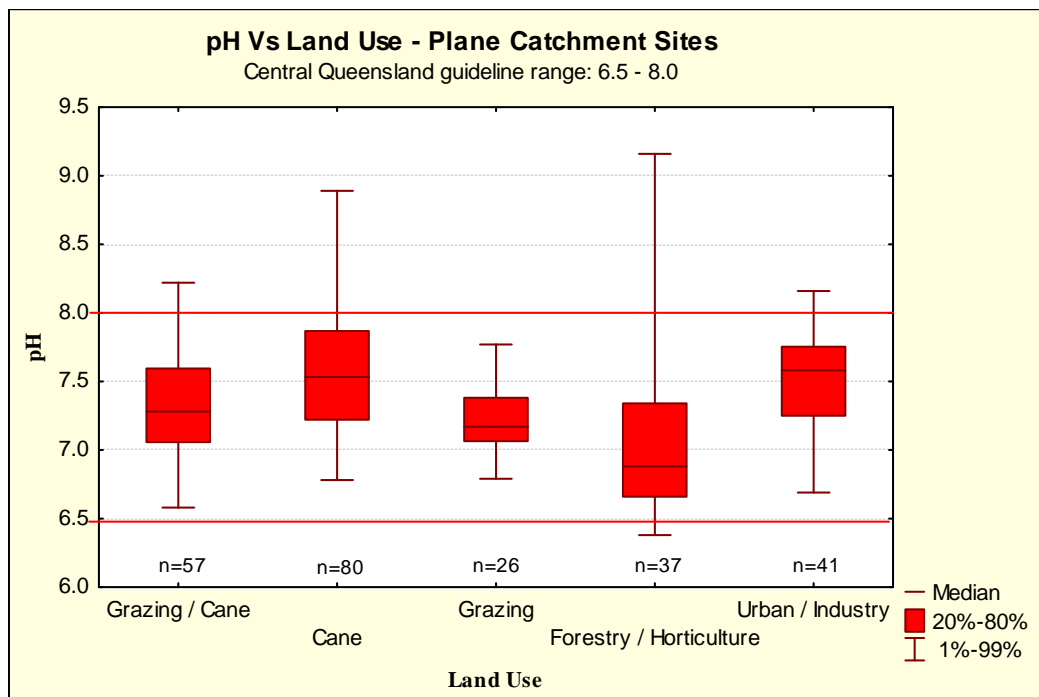
**Figure 41 pH Vs Land use – Plane catchment sites**

Median values for land use types ranged between 6.88 and 7.6, with the forestry / horticulture site (Middle Creek Dam) portraying the lowest median and the urban / industry site (Plane Creek) having the highest median value (Figure 41). Middle Creek Dam on Plane Creek had the greatest pH range. The dam environment (Middle Creek Dam) experiences rapid water inundation alternating with prolonged dry periods.

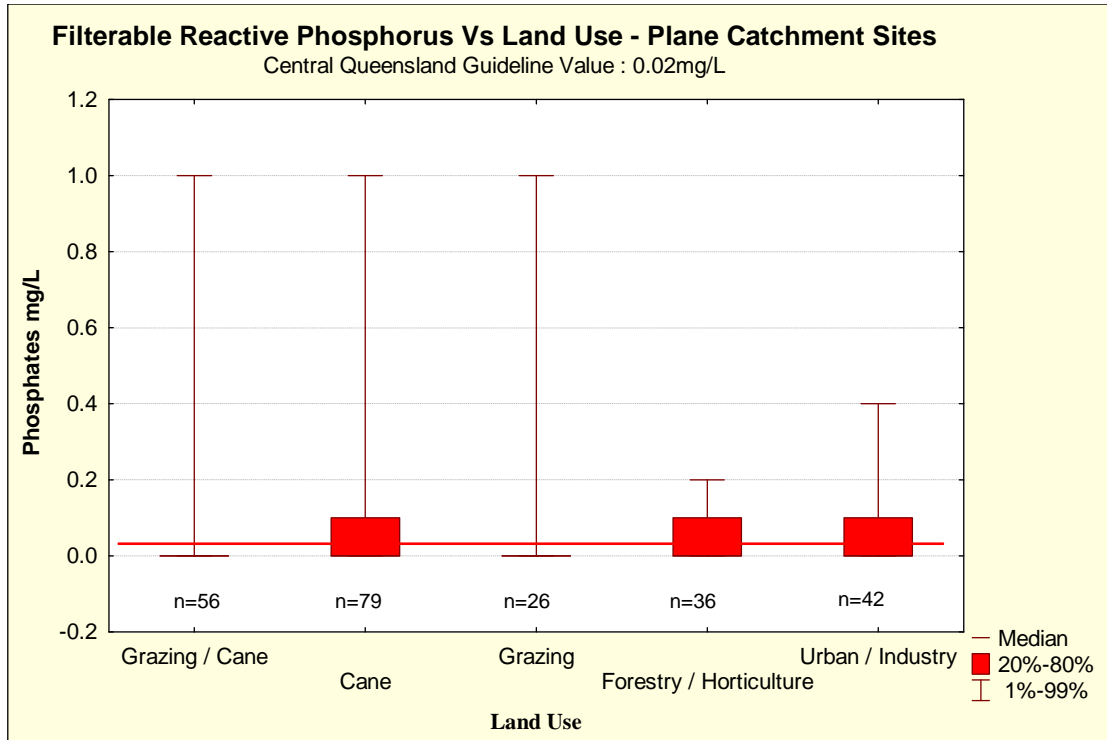
Figure 43 Filterable reactive phosphorus Vs Land use – Plane catchment sites

Grazing / cane, cane and grazing sites all exhibited readings of 1 mg/L at certain times of the year (Figure 43). Forestry / horticulture and urban / industry sites had readings of 0.1 mg/L for 80% of the time but reached maxima of 0.2 mg/L and 0.4 mg/L on some occasions.

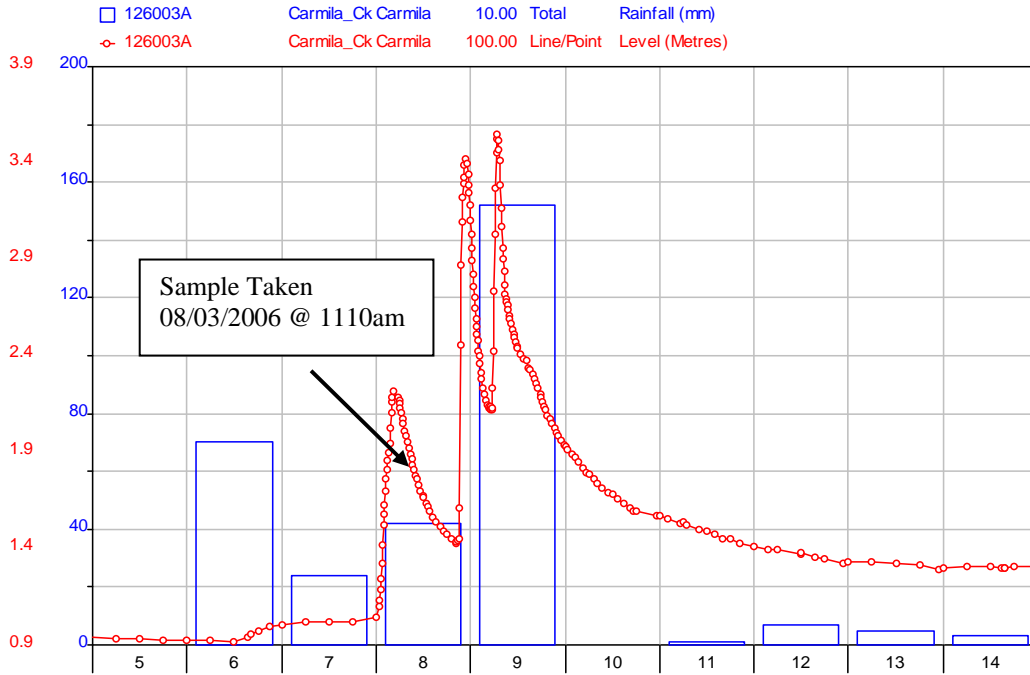
**Figure 44 Carmila Creek hydrograph and rainfall plot showing the point at which the sample was collected.**

Recorded comments for Carmila Creek – Streeters Road indicates that the water level was very high and turbid on March 8<sup>th</sup>, 2006. The sample had to be taken from the car due to the inundation of the usual sampling site. This was caused by 135mm of rain falling within 3 days prior to sampling. This rainfall caused the creek to rise more than 1m (Figure 44).
