5. Conclusions and Recommendations

5.1 Conclusions

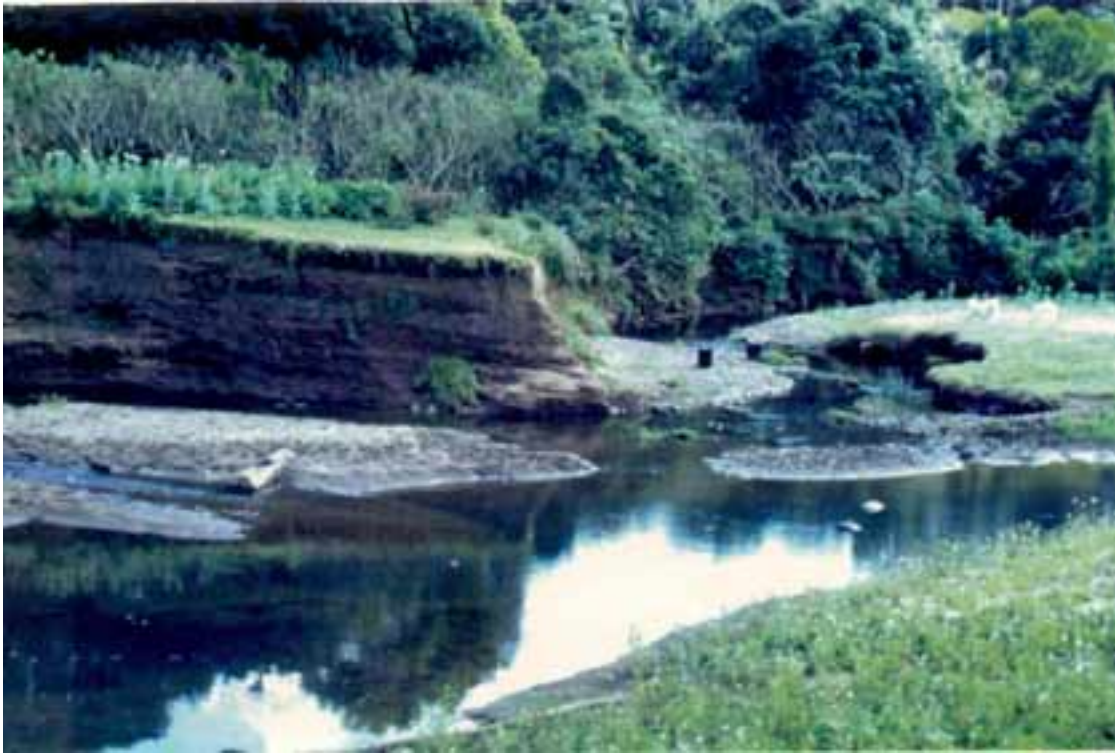
Upstream Site Highly Degraded by loss of Riparian Vegetation - Site 11 Petrie Creek, Menarys Rd.

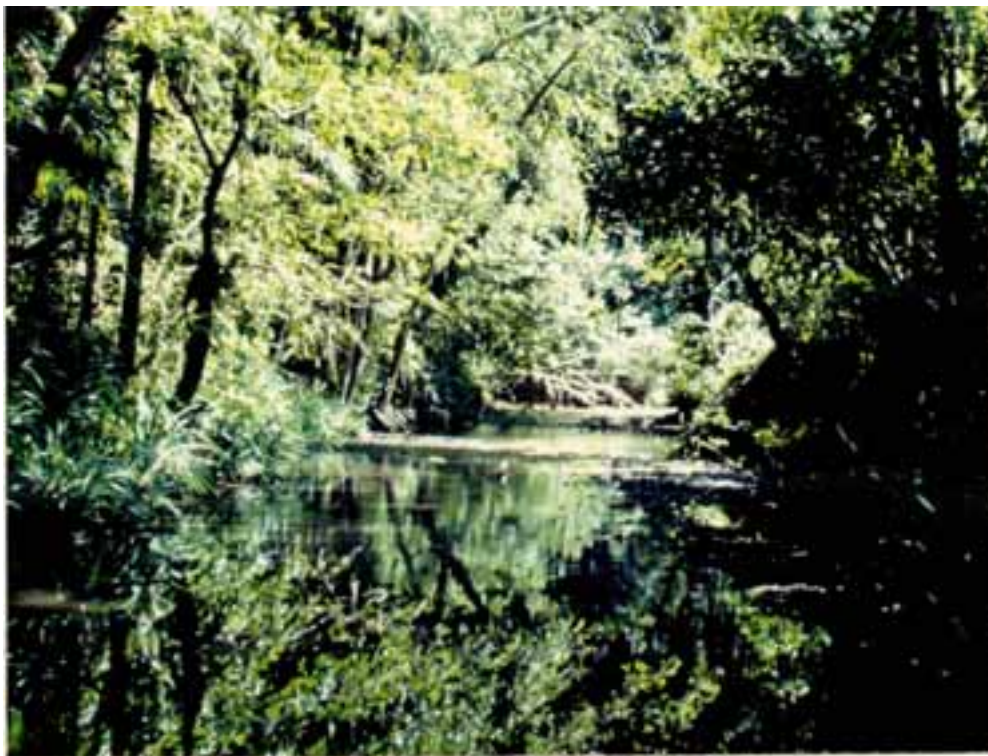
Downstream Site protected from bank erosion by retention of Riparian Vegetation
- Site 27 Petrie Creek, about 2 km downstream of Site 11
