ECOLOGICAL AND PHYSICAL CONDITION OF THE LOGAN RIVER AND TRIBUTARIES

G I Moller

Resource Sciences Centre
Department of Natural Resources

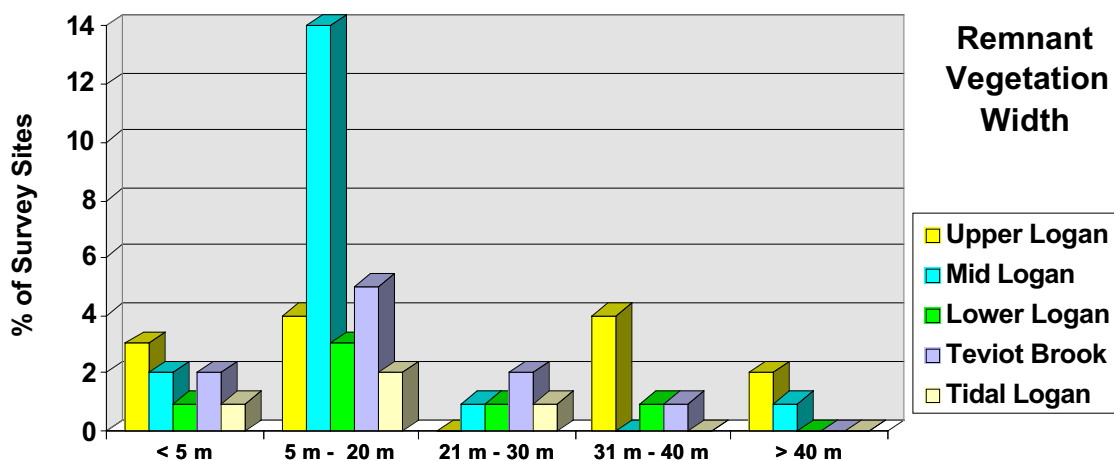
Figure 6 Remnant Vegetation Width

Within the Upper Logan subcatchment the stream banks were bare of vegetation for a mean of 9% of the bank length. The vegetation was highly disturbed having a mean remnant vegetation width of 22 metres, Figure 6, and mean riparian vegetation width of 10 metres. The structural composition of the riparian vegetation is shown in Table 8, along with the presence of exotic species in the vegetation. The most frequently recorded species are listed in Table 9.

The Mid Logan subcatchment stream banks were bare of vegetation for a mean of 11% of the bank length. The vegetation was highly disturbed having a mean riparian vegetation width of 8 metres and a mean remnant vegetation width of 13 metres, Figure 6, which shows the distribution of the remnant vegetation in the subcatchments. The structural composition of the riparian vegetation is shown in Table 8, along with the presence of exotic species in the vegetation. The most frequently recorded species are listed in Table 9.

The Lower Logan subcatchment stream banks were bare of vegetation for a mean of 24% of the bank length. The vegetation was highly disturbed having a mean riparian vegetation width of 7 metres and a mean remnant vegetation width of 15 metres, Figure 6, which shows the distribution of the remnant vegetation in the subcatchments. The structural composition of the riparian vegetation is shown in Table 8, along with the presence of exotic species in the vegetation. The most frequently recorded species are listed in Table 9.

The Teviot Brook subcatchment stream banks were bare of vegetation for a mean of 11% of the bank length. The vegetation was highly disturbed having a mean riparian vegetation width of 10 metres and a mean remnant vegetation width of 15 metres, Figure 6, which shows the distribution of the remnant vegetation in the subcatchments. The structural composition of the riparian vegetation is shown in Table 8, along with the presence of exotic species in the vegetation. The most frequently recorded species are listed in Table 9.

The Tidal Logan subcatchment stream banks were bare of vegetation for a mean of 18% of the bank length. The vegetation was highly disturbed having a mean riparian vegetation width of 5 metres and a mean remnant vegetation width of 10 metres, Figure 6, which shows the distribution of the remnant vegetation in the subcatchments. The structural composition of the riparian vegetation is shown in Table 8, along with the presence of exotic species in the vegetation. The most frequently recorded species are listed in Table 9.

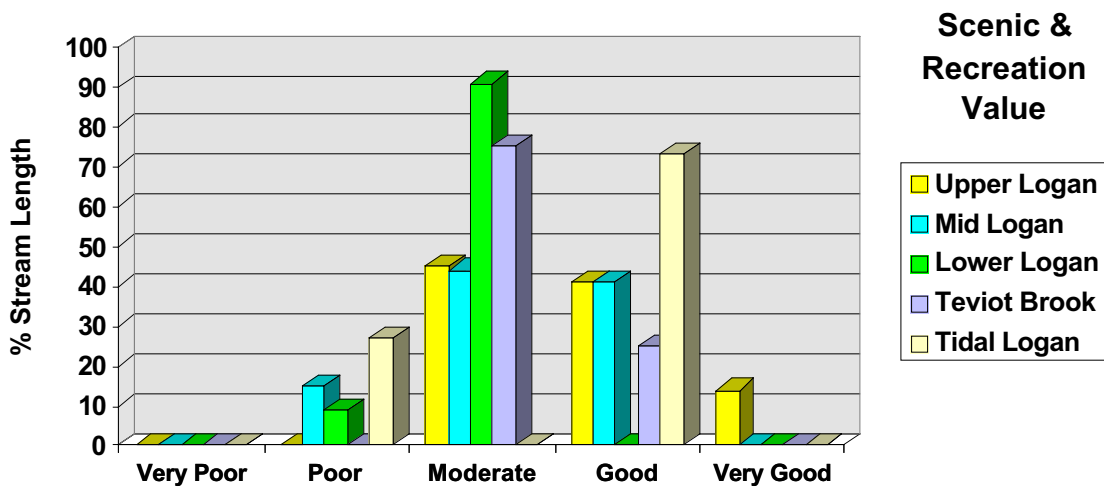
Figure 9 Scenic & Recreation Value

The scenic and recreation values of the subcatchments have been assessed to be Moderate to Good, Figure 9, with no stream length rated Very Poor and 14% of stream length in the Upper Logan subcatchment rated Very Good, Table 6.

Recreational opportunity was mostly in Undeveloped Rural settings, with 3 sites in Roaded Natural, 1 site Near Natural and 1 site each Developed Rural, Undeveloped Urban and Developed Urban. The recreation activities which could take place within the subcatchments was mostly shore fishing, swimming or appreciation of the local setting. There were sites in the Upper Logan subcatchment which allowed camping, picnicking, bushwalking and appreciation of nature. The Tidal Logan subcatchment had more recreation in the marine type of environment with larger boats, canoeing, sailing and water skiing.
